**Subject: Pre-Renovation Hazardous Building Materials Survey
Former A-1 Deli
88-92 Merrimack Street, Haverhill, Massachusetts**

Draft Pre-Renovation Hazardous Building Materials Survey

**Former A-1 Deli
88-92 Merrimack Street
Haverhill, Massachusetts 01830**

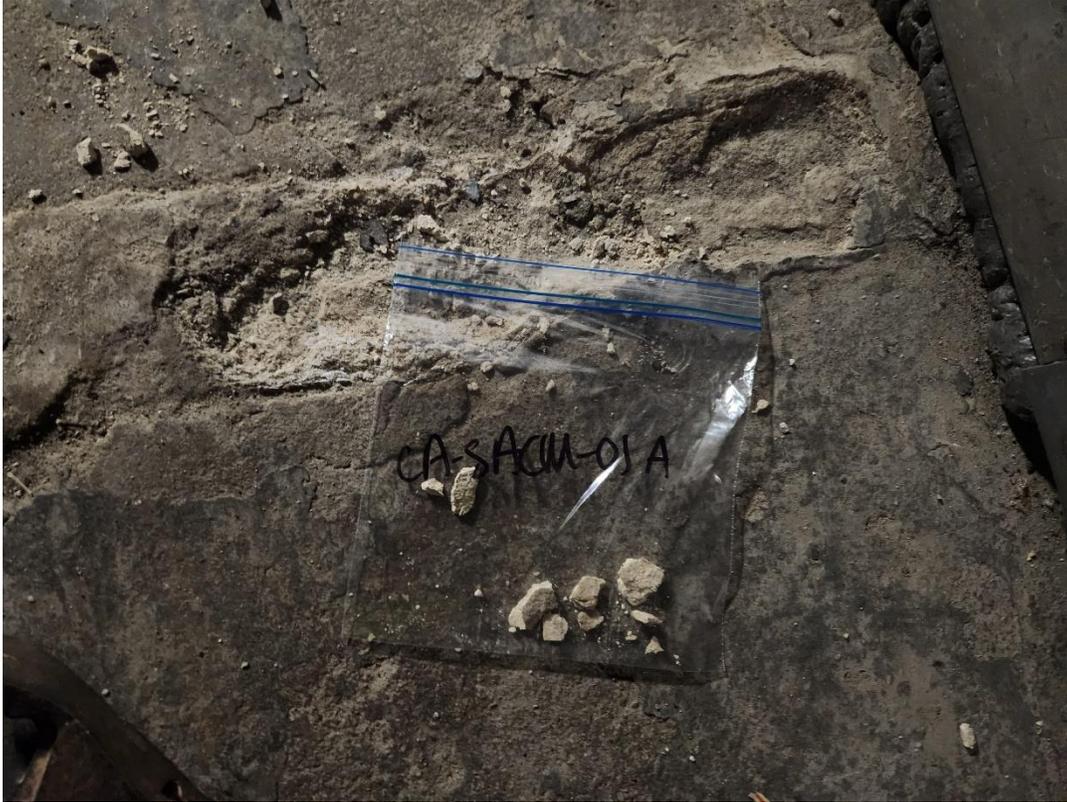
1. View of CA-SACM-01, concrete, gray

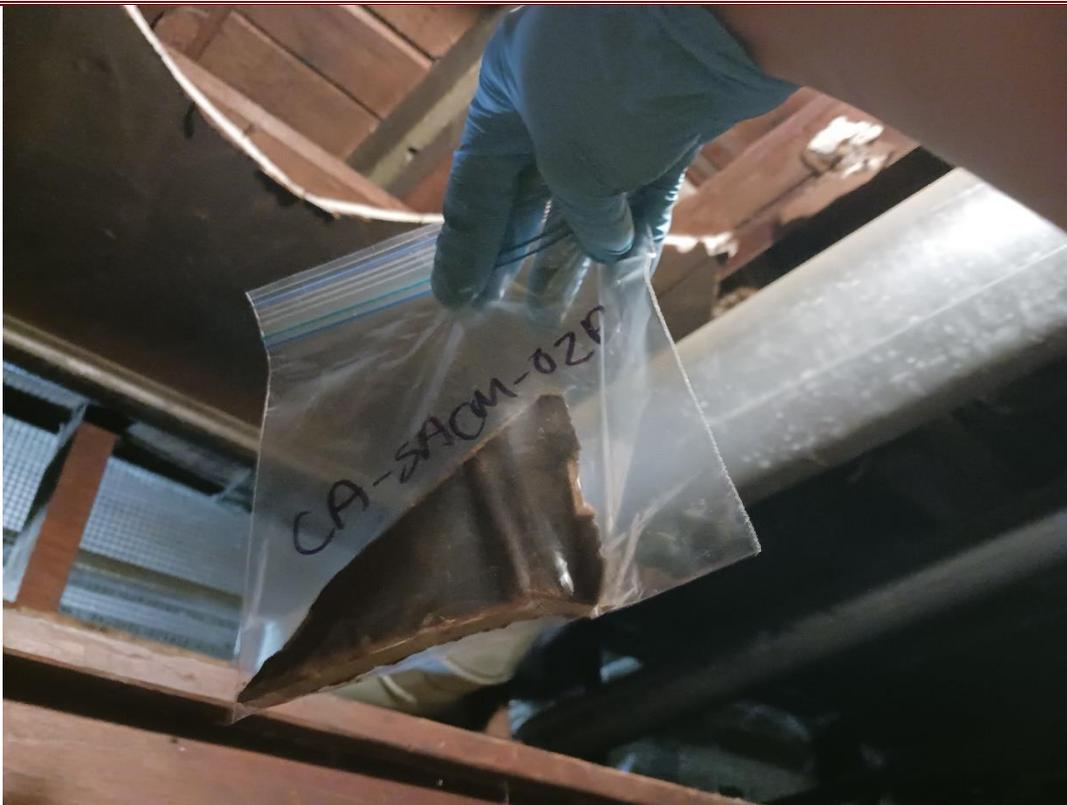
2. View of CA-SACM-02, sheetrock, white

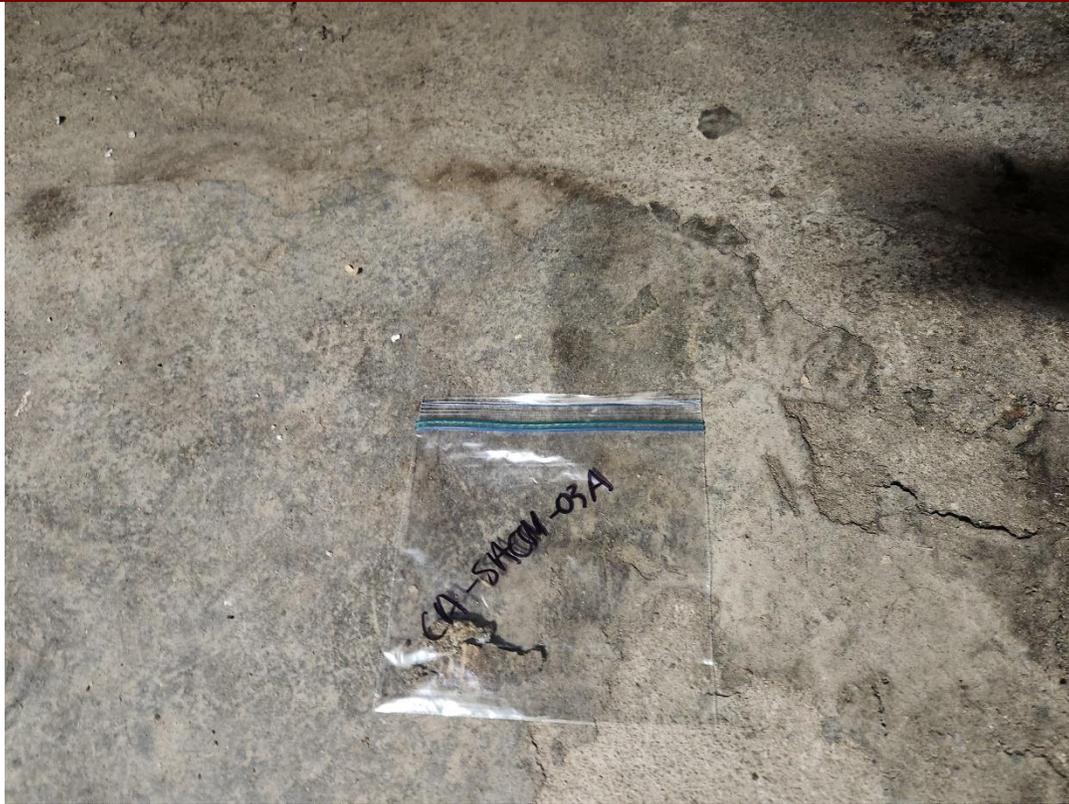
3. View of CA-SACM-03, floor coating, dark gray

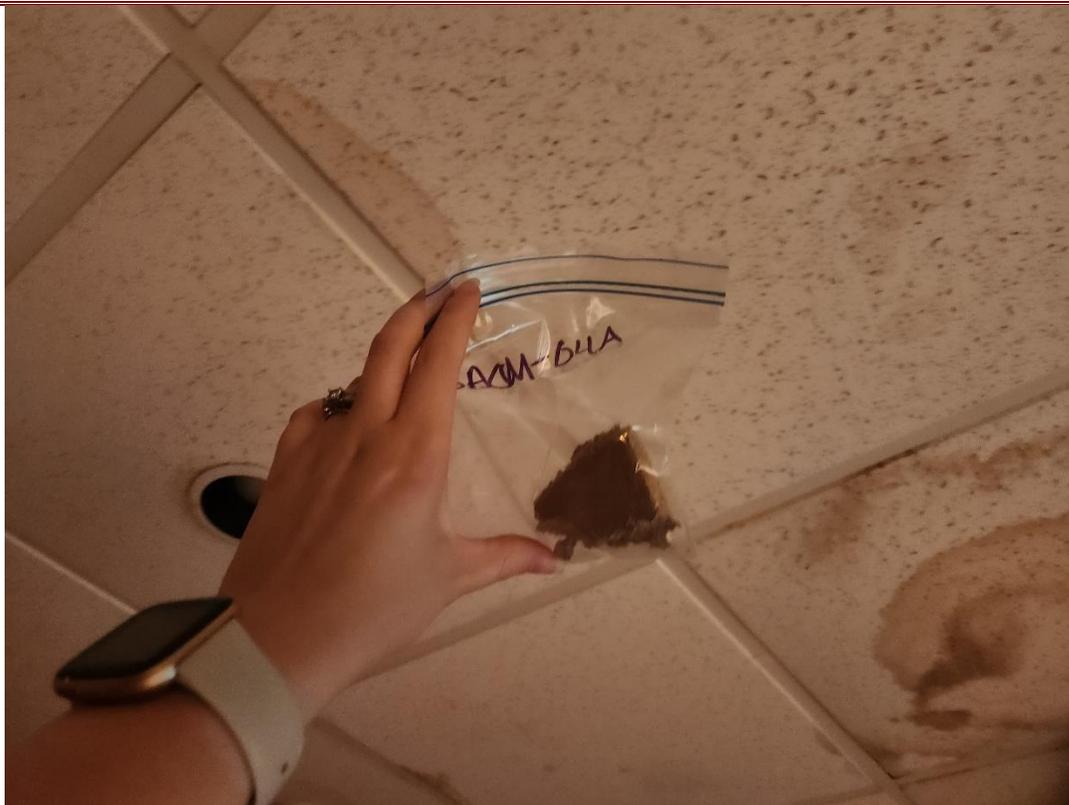
4. View of CA-SACM-04, 2x2 ceiling tile, gray

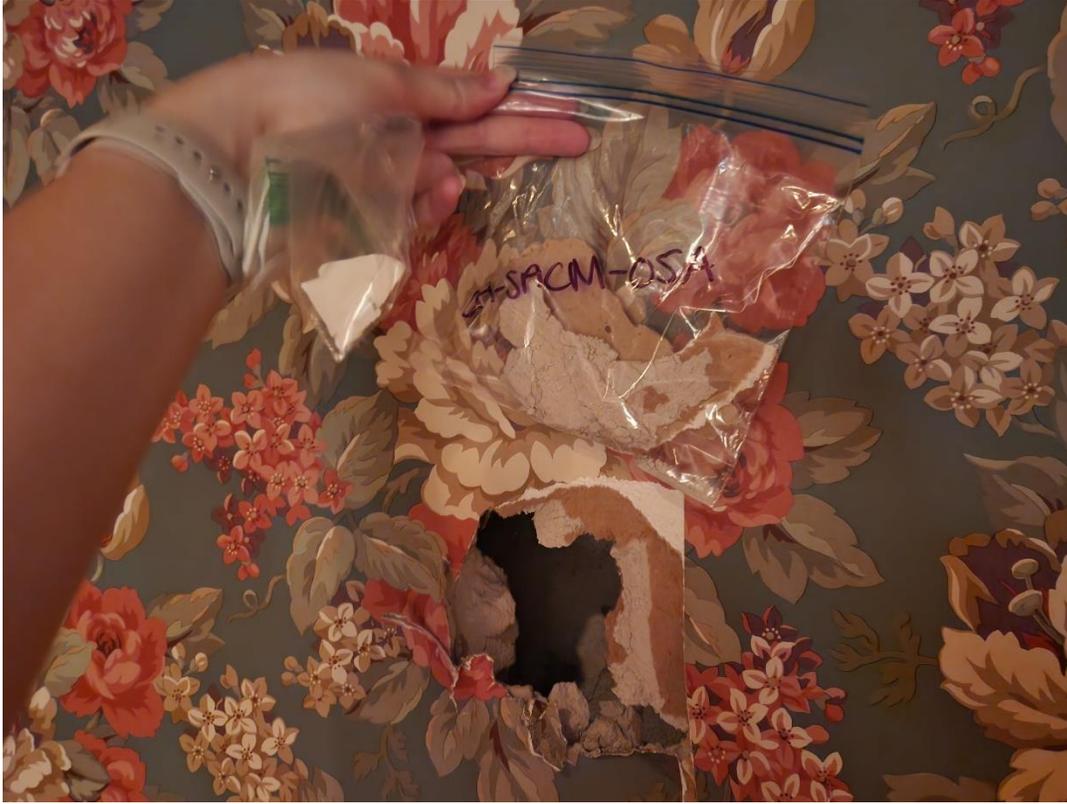
5. View of CA-SACM-05, sheetrock, light gray

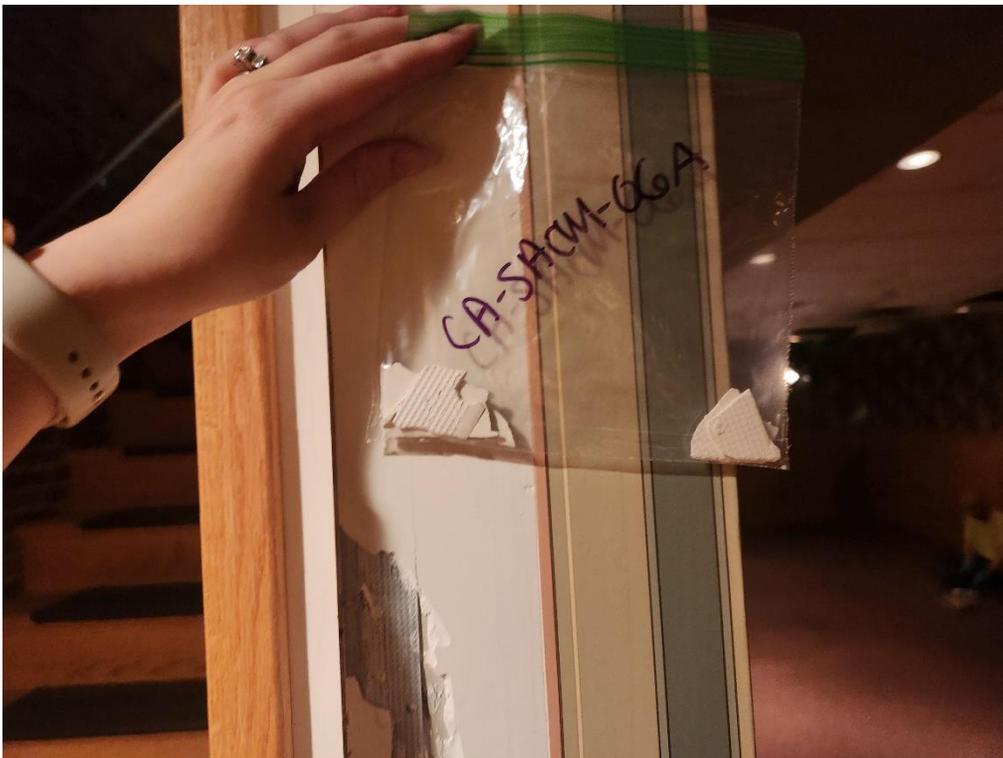
6. View of CA-SACM-06, joint compound, white

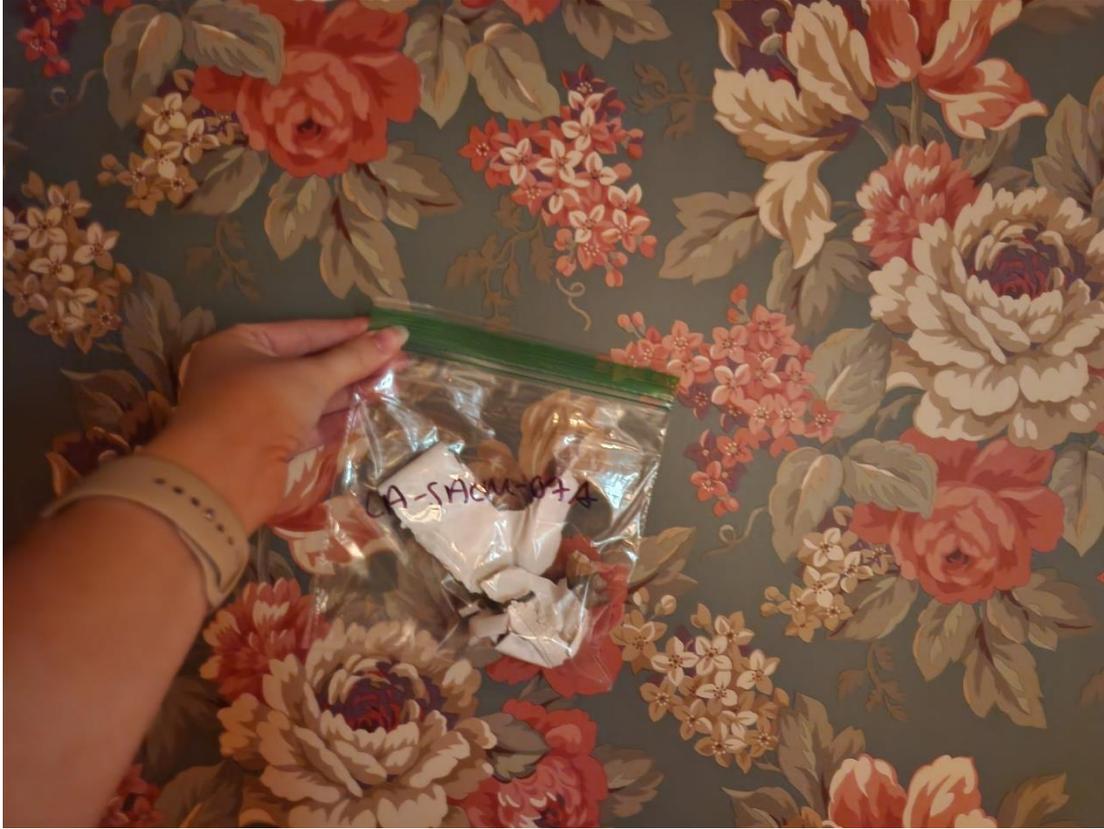
7. View of CA-SACM-07, floral wallpaper, various colors

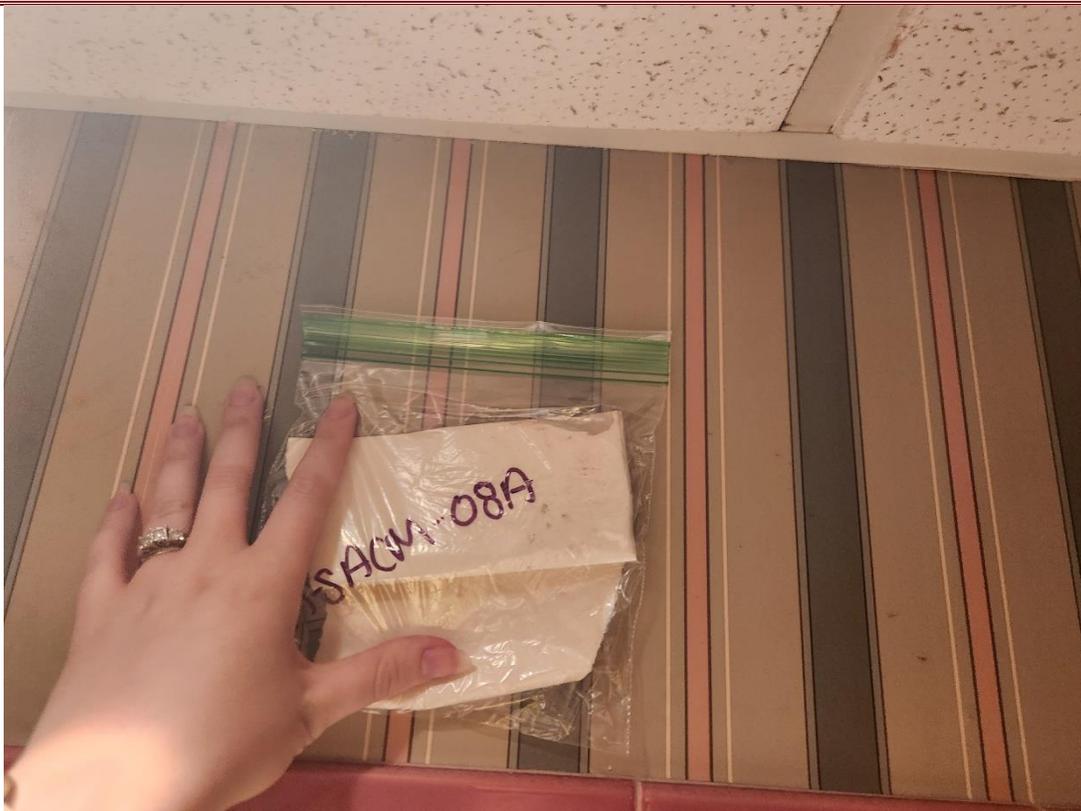
8. View of CA-SACM-08, striped wallpaper, various colors

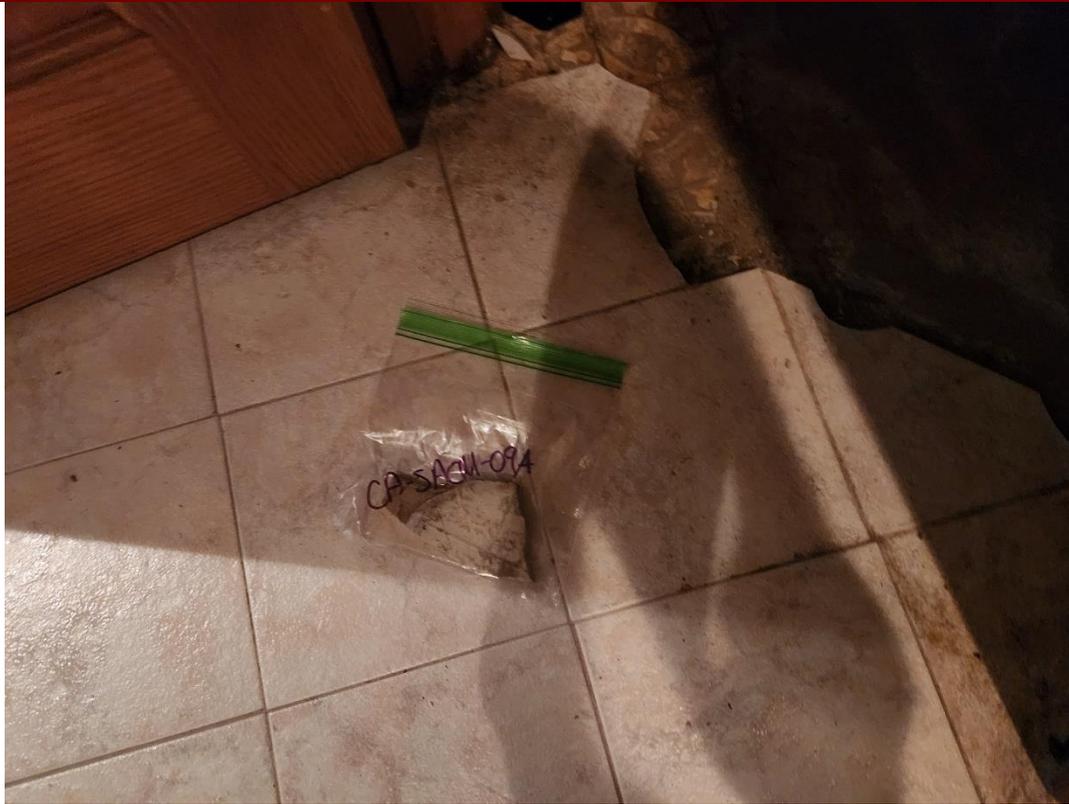
9. View of CA-SACM-09, tile underlayment, gray

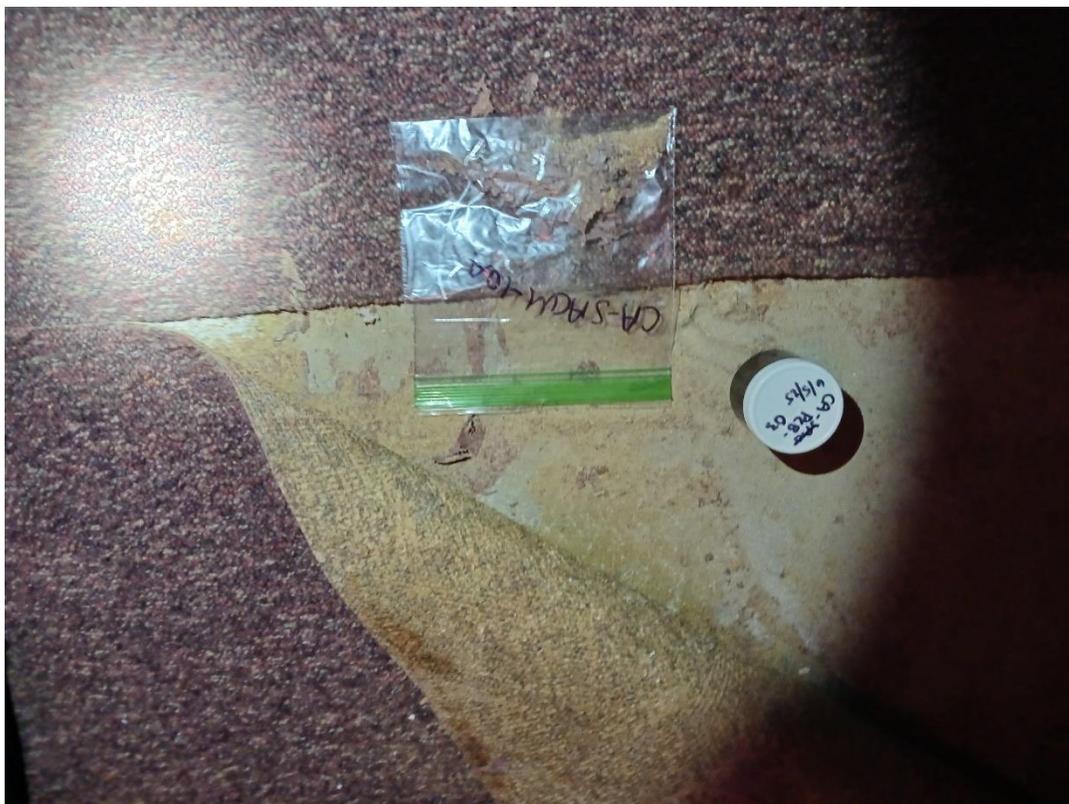
10. View of CA-SACM-10 and CA-PCB-03, carpet adhesive, yellow

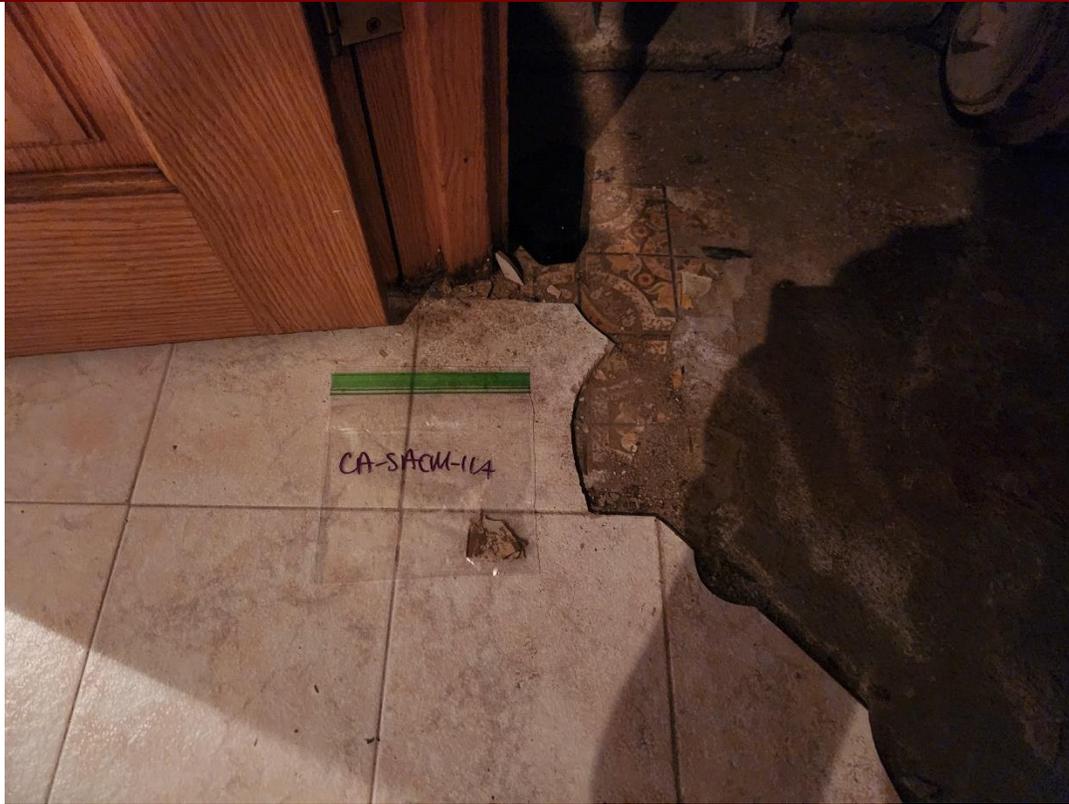
11. View of CA-SACM-11, linoleum, various colors

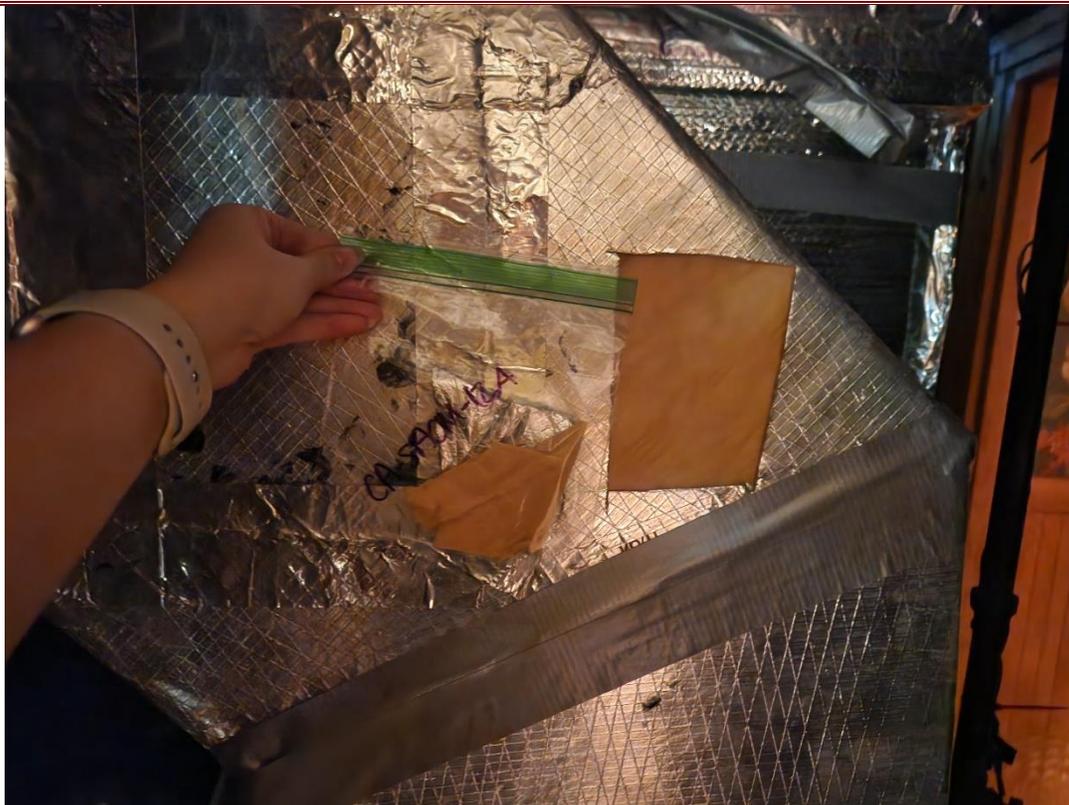
12. View of CA-SACM-12, paper, silver

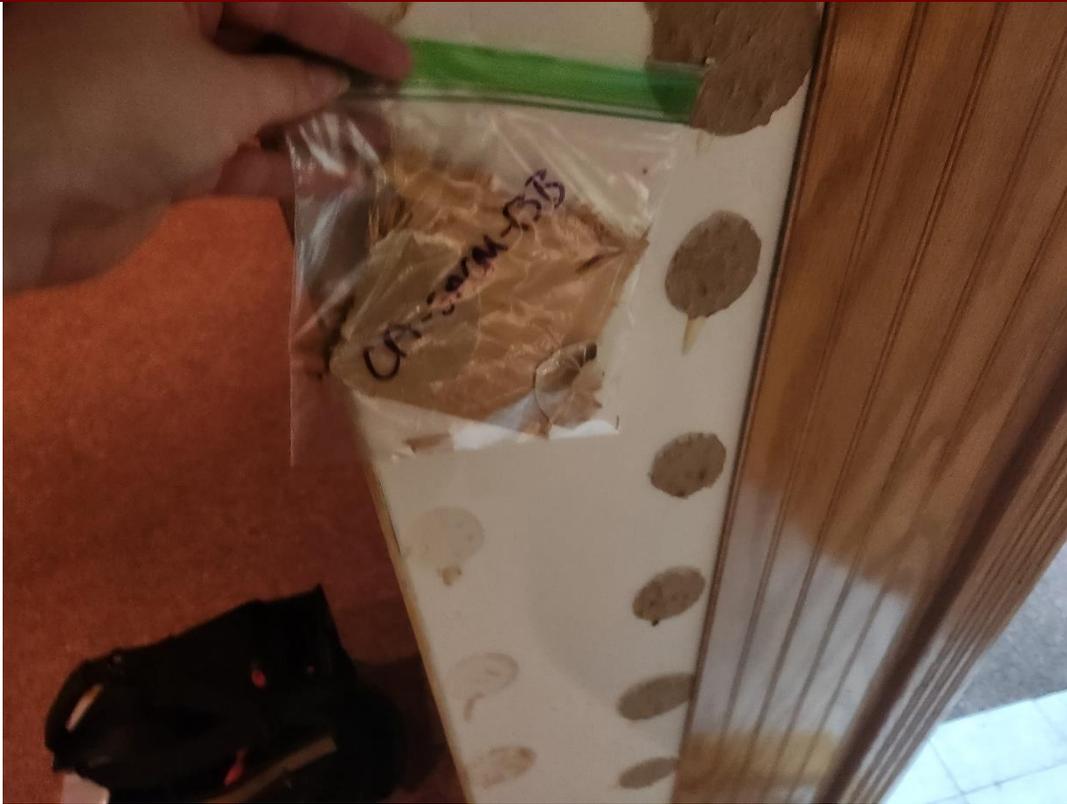
13. View of CA-SACM-13, wainscoting adhesive, yellow

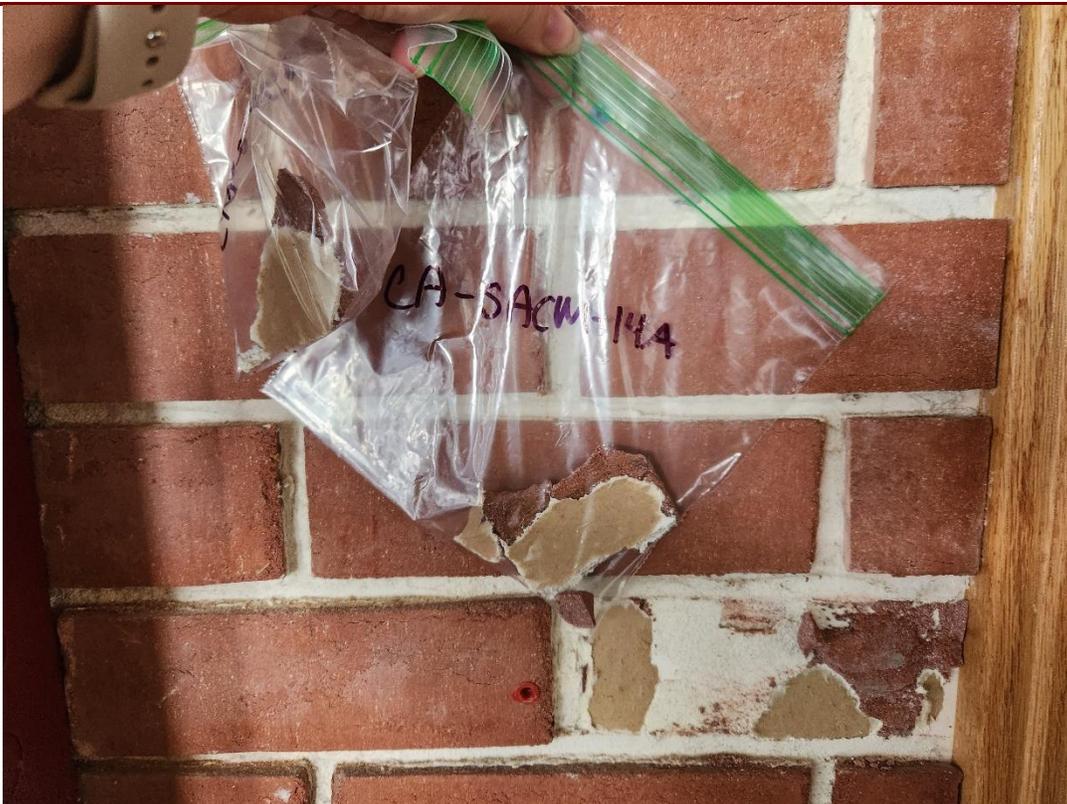
14. View of CA-SACM-14, brick adhesive, gray

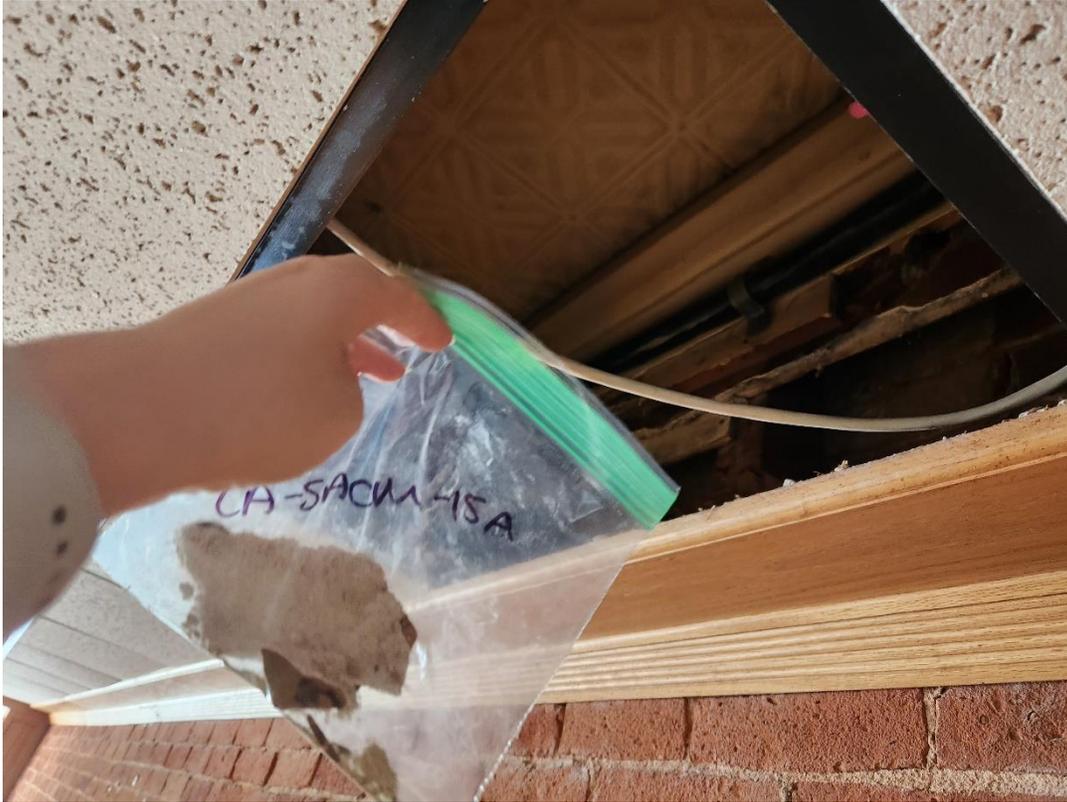
15. View of CA-SACM-15, plaster, gray

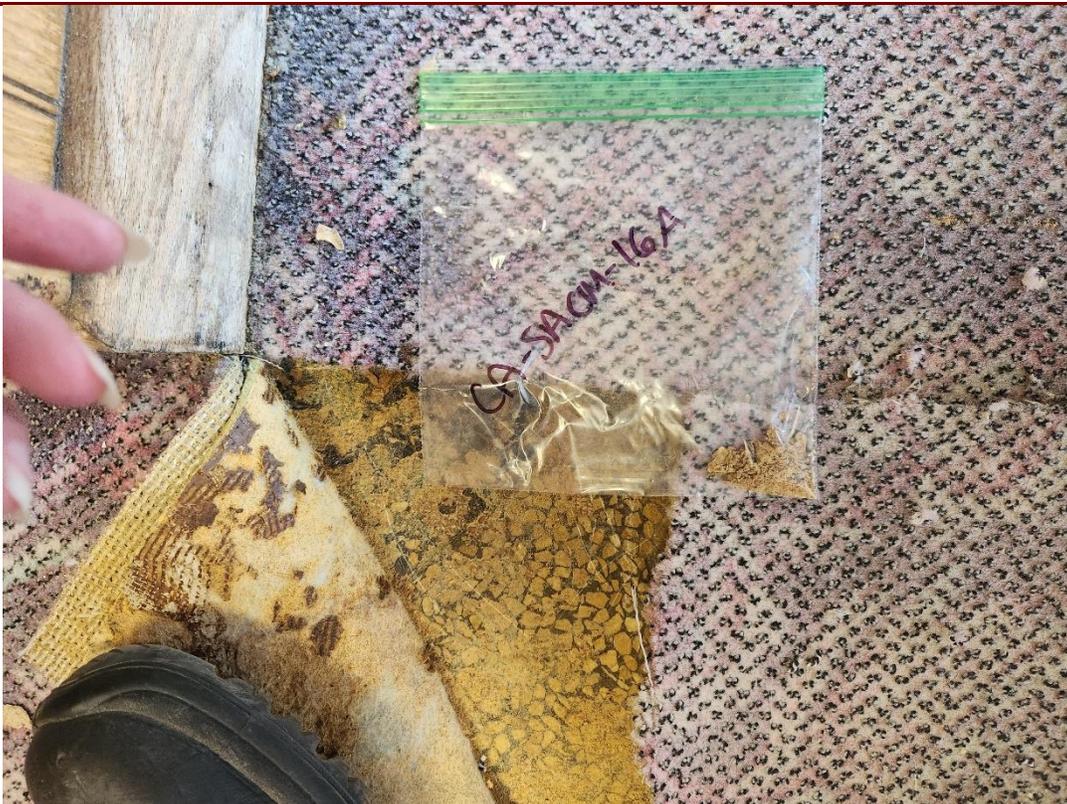
16. View of CA-SACM-16, carpet adhesive, yellow

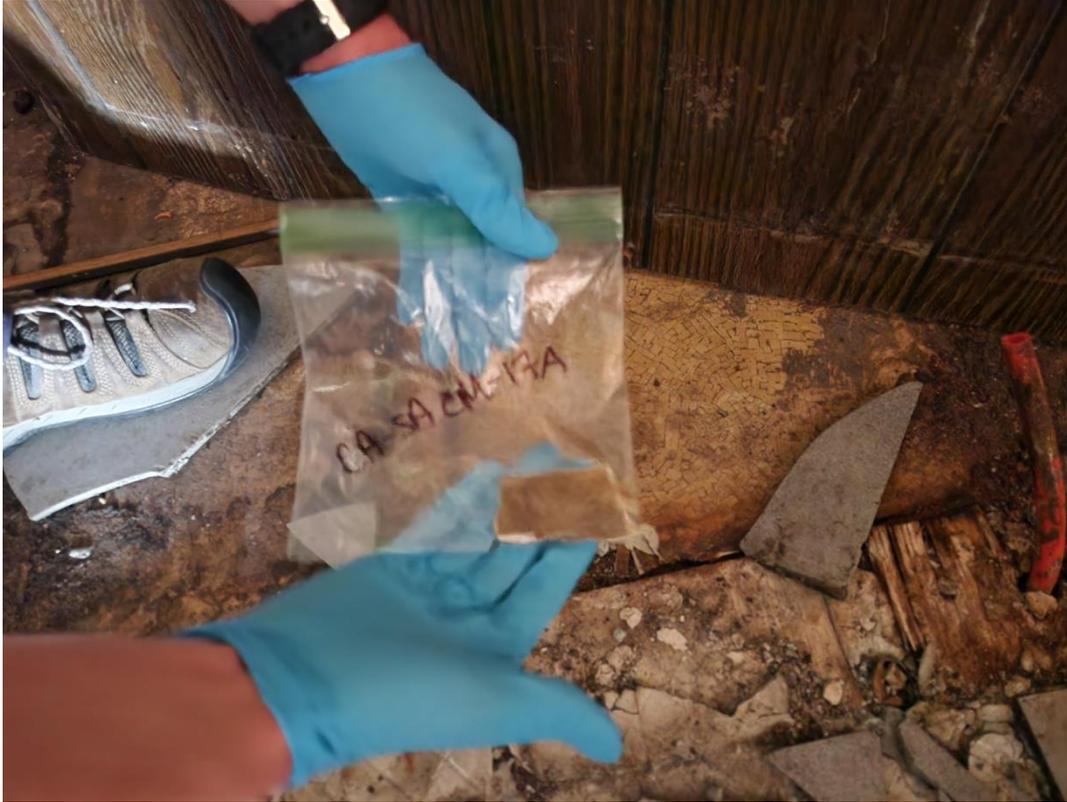
17. View of CA-SACM-17, linoleum, brown/various colors

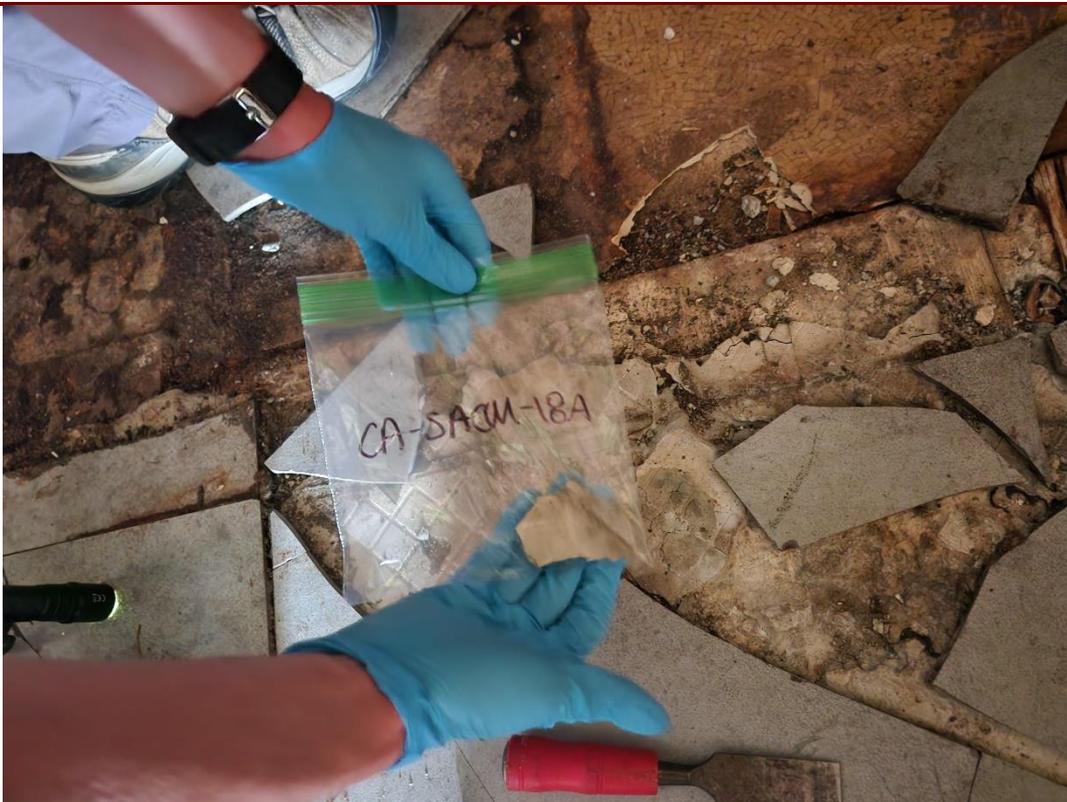
18. View of CA-SACM-18, 1x2 tile underlayment, gray

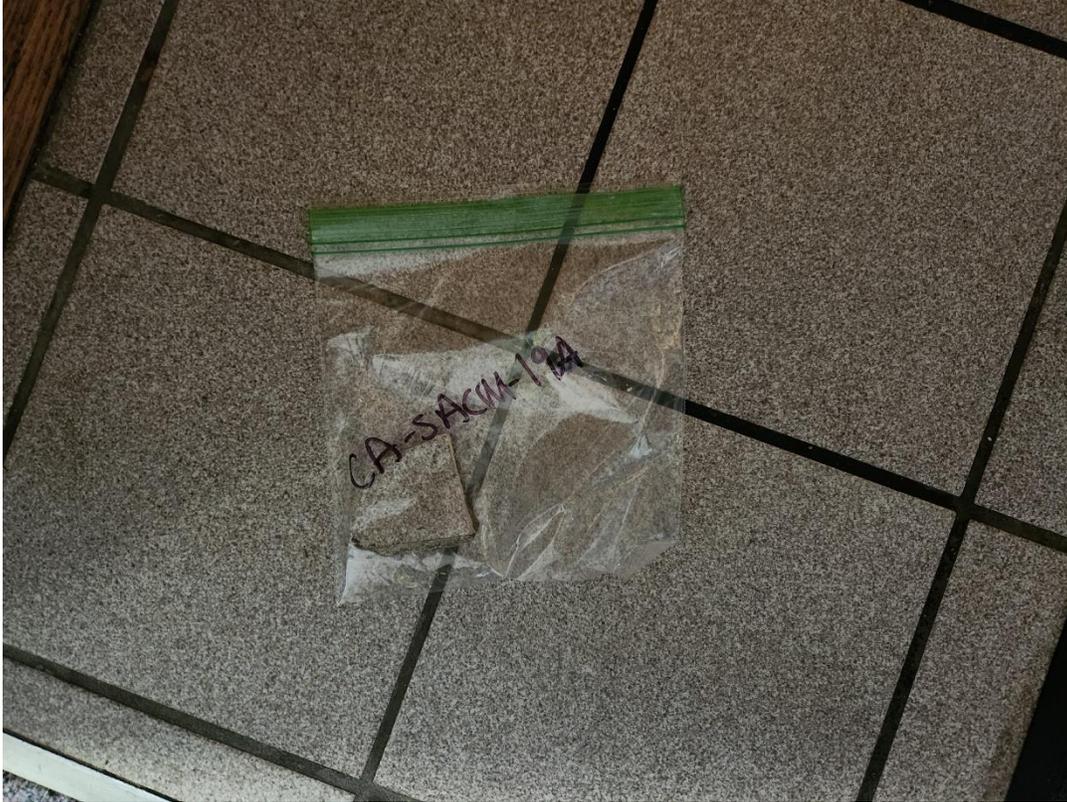
19. View of CA-SACM-19, 9" tile underlayment, gray

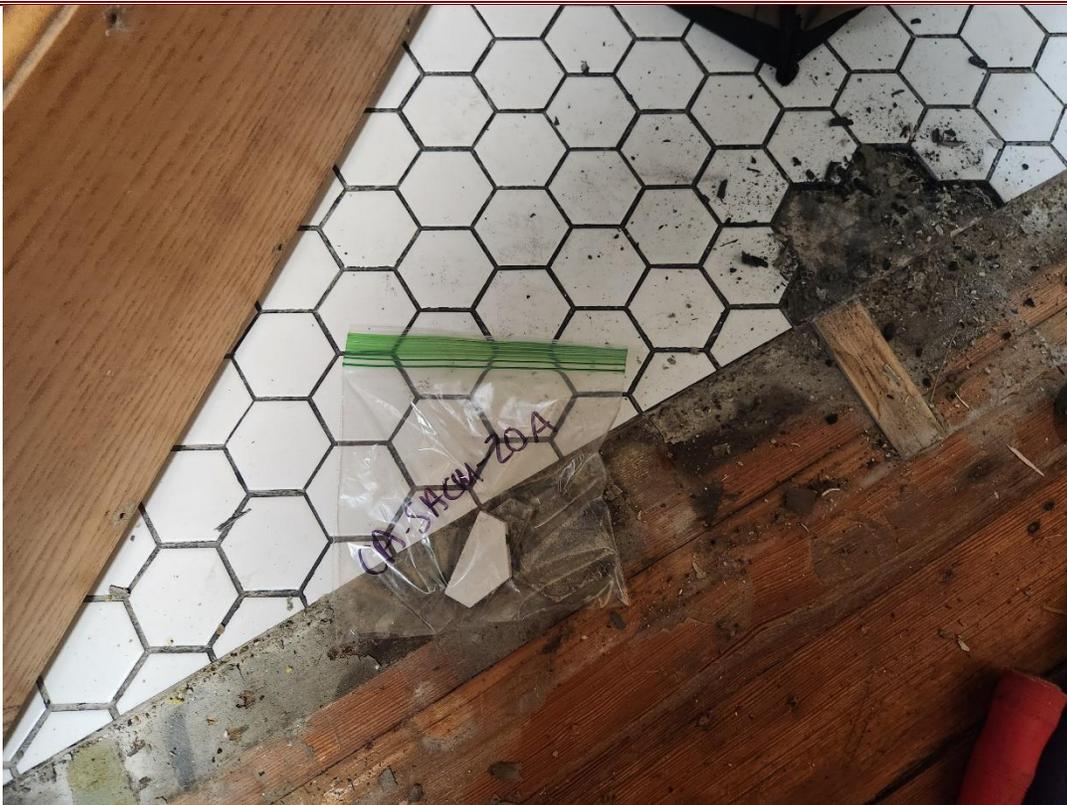
20. View of CA-SACM-20, tile underlayment, gray

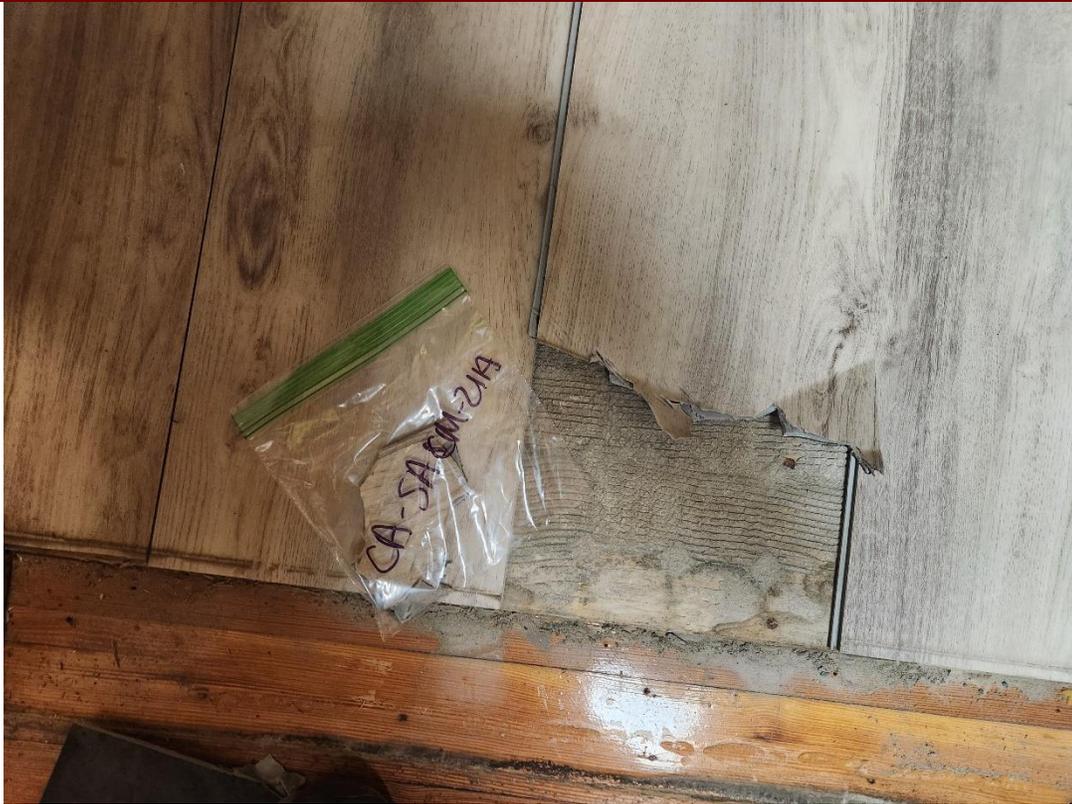
21. View of material for CA-SACM-21, faux wood flooring, light gray

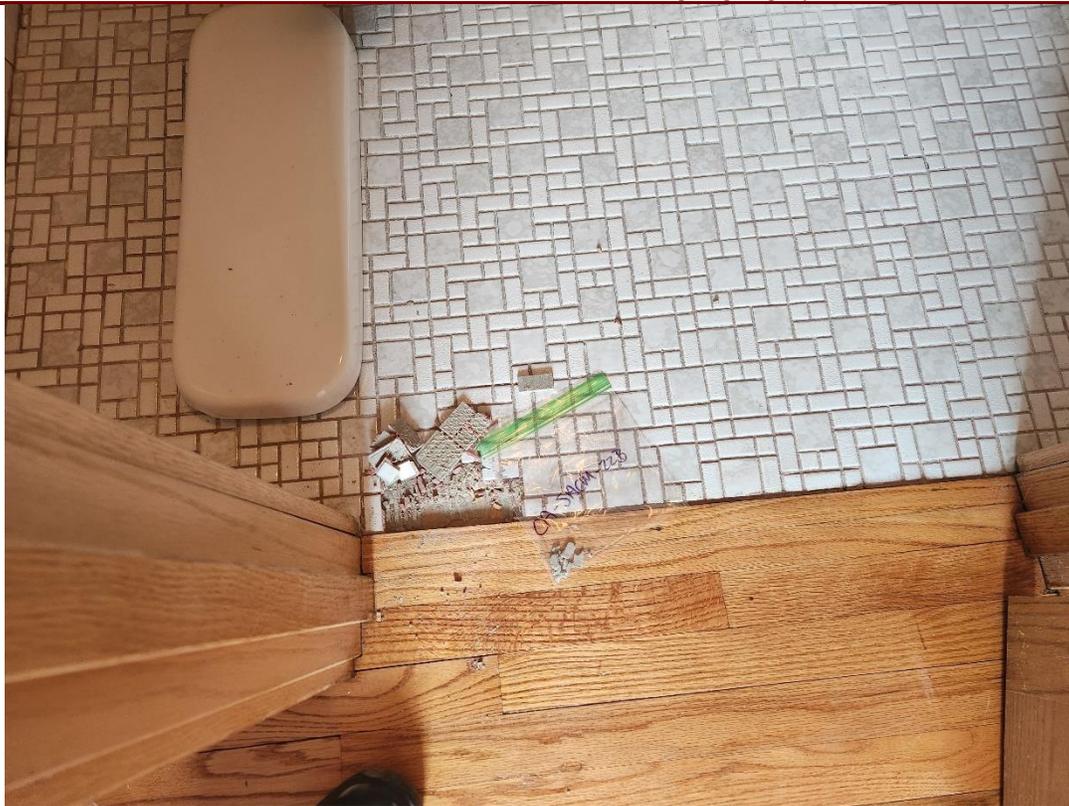
22. View of material for CA-SACM-22, tile underlayment, gray

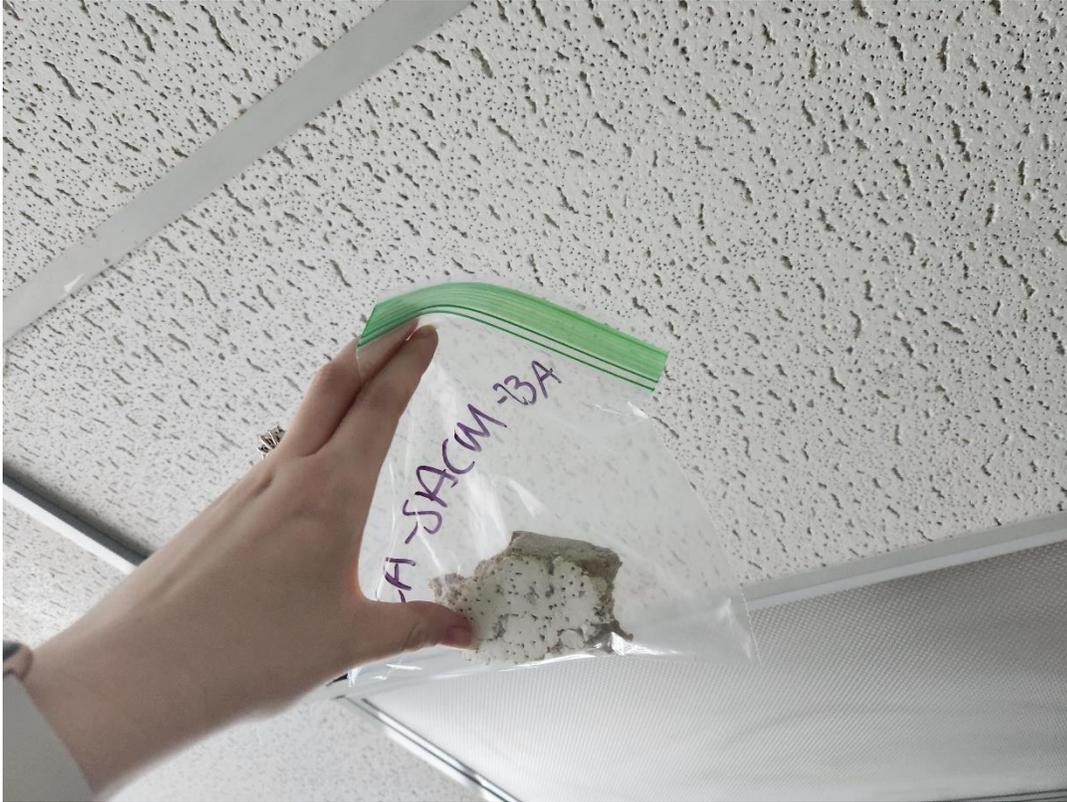
23. View of CA-SACM-23, 2x3 ceiling tile, gray

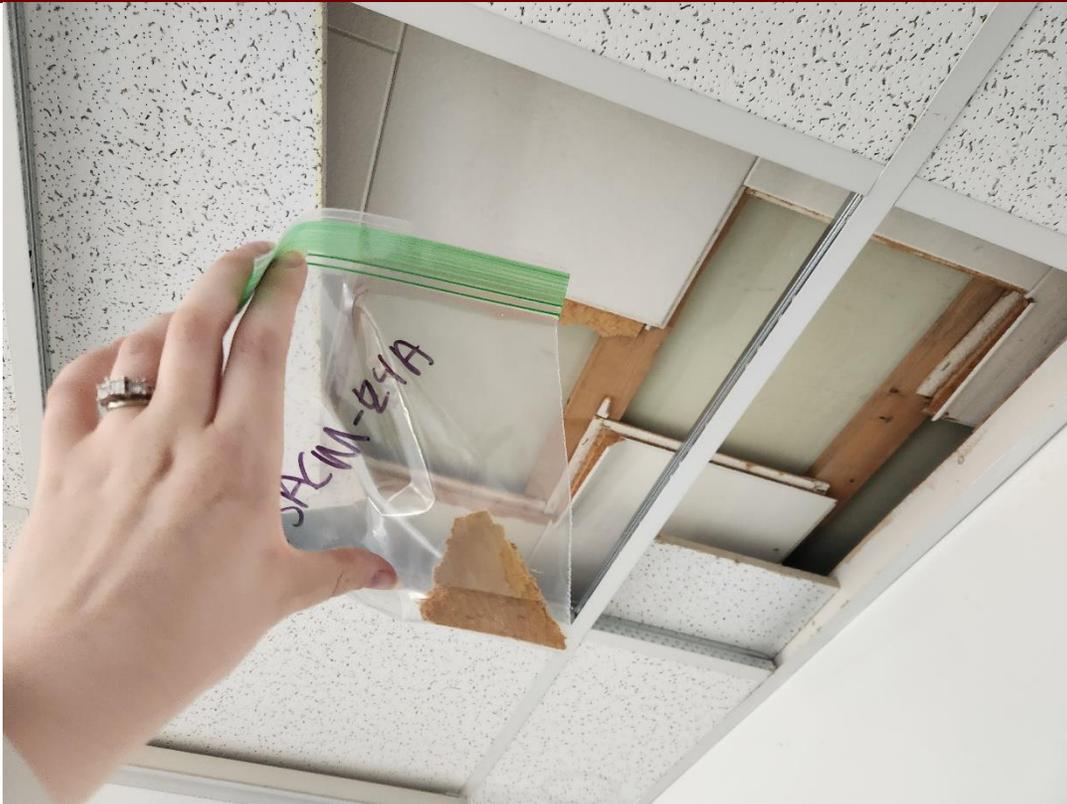
24. View of CA-SACM-24, 12" ceiling tile, brown

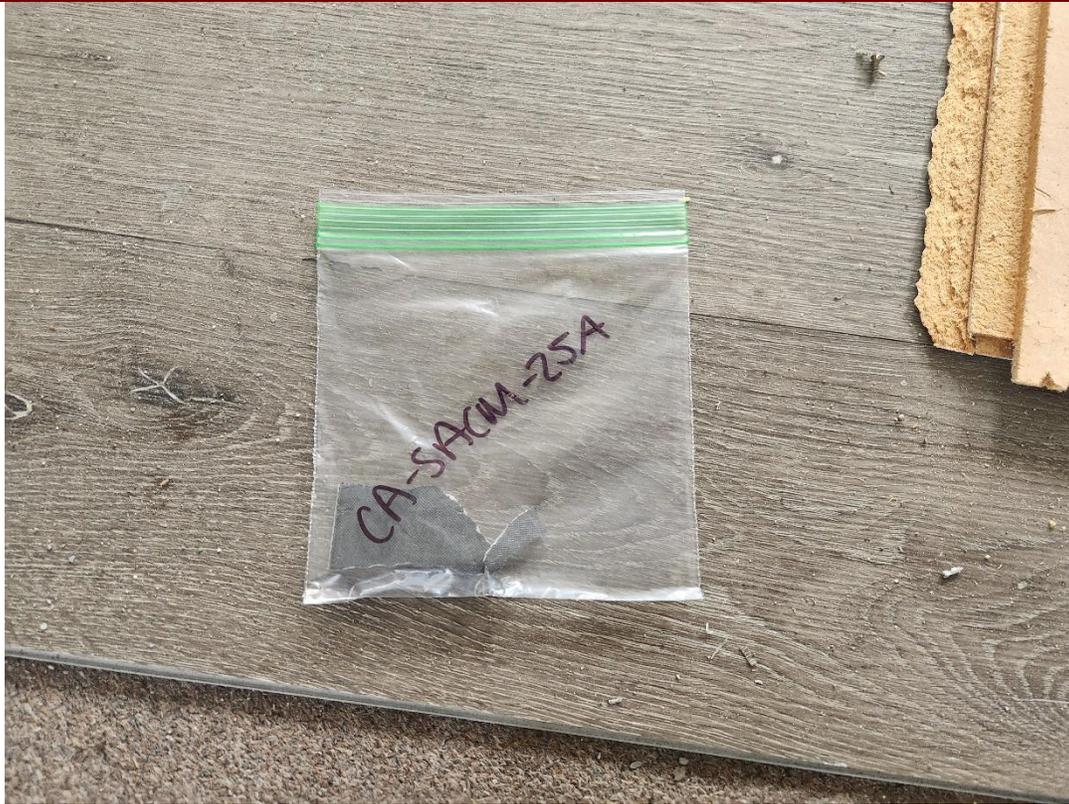
25. View of CA-SACM-25, faux wood flooring, dark gray

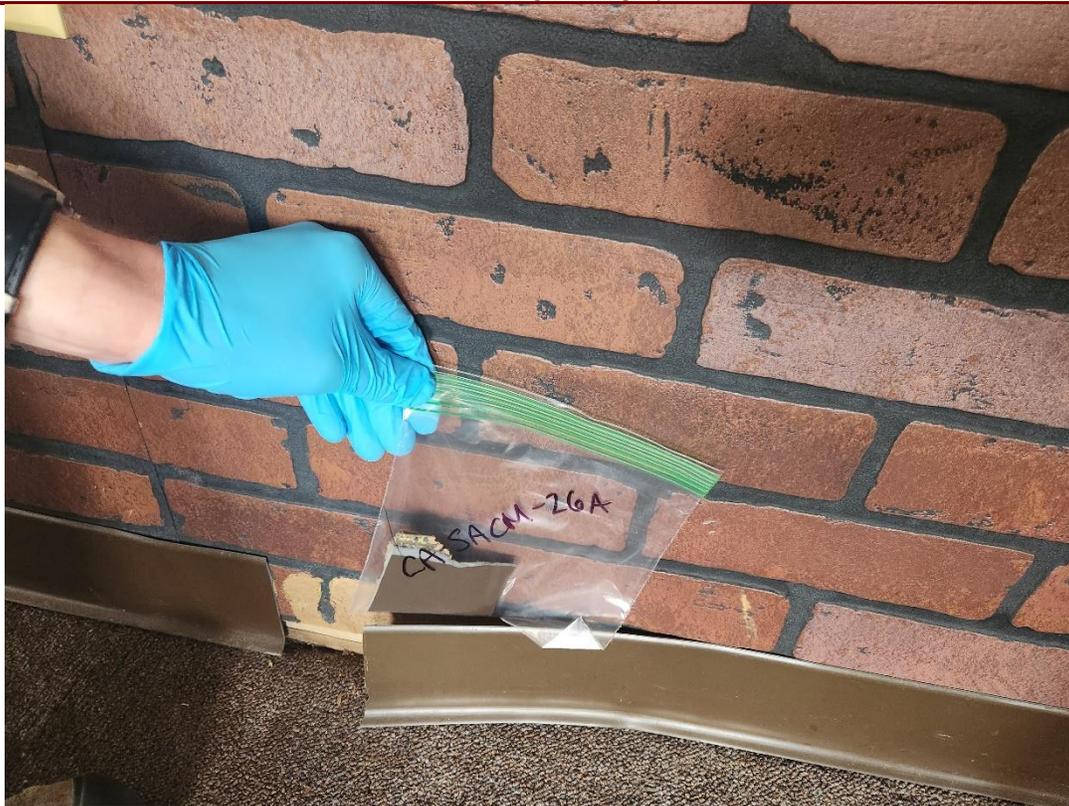
26. View of CA-SACM-26, base adhesive, yellow
