**Subject: Pre-Renovation Hazardous Building Materials Survey
Former A-1 Deli
88-92 Merrimack Street, Haverhill, Massachusetts**

Draft Pre-Renovation Hazardous Building Materials Survey

**Former A-1 Deli
88-92 Merrimack Street
Haverhill, Massachusetts 01830**

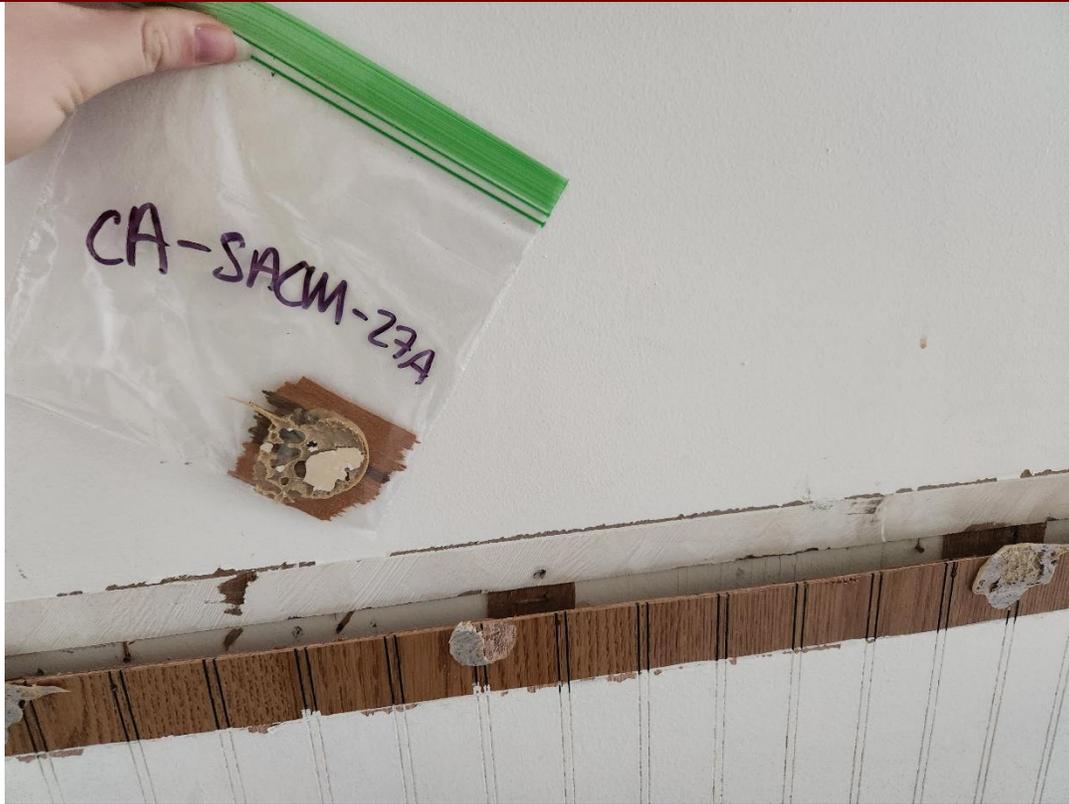
27. View of CA-SACM-27, paneling adhesive, beige

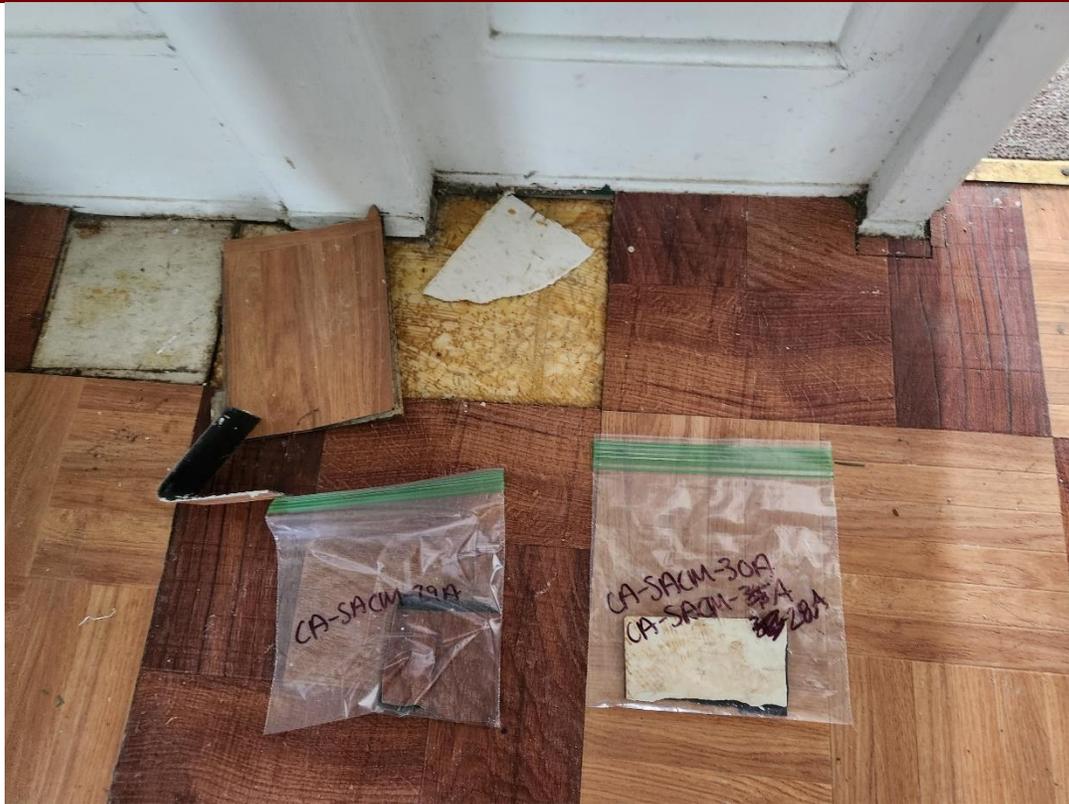
28. View of CA-SACM-28, 12" floor tile, light brown pattern #1, CA-SACM-29, 12" floor tile dark brown pattern #1, and CA-SACM-30, 12" floor tile, white

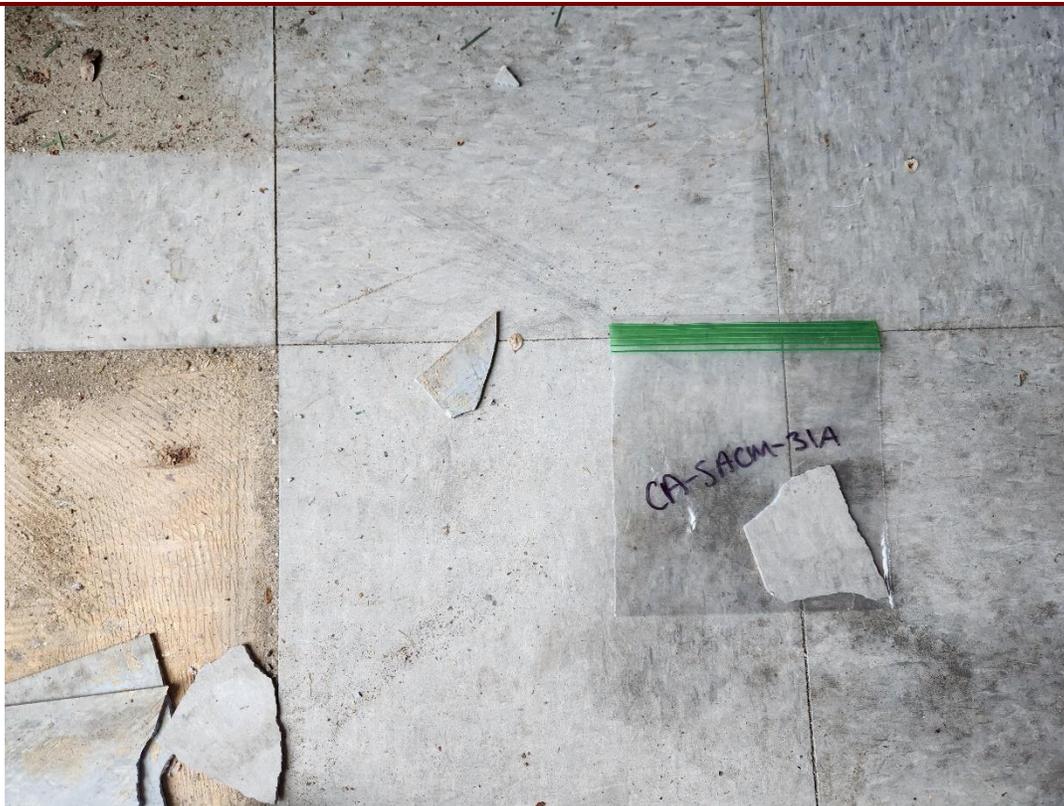
29. View of CA-SACM-31, 12” floor tile, blue

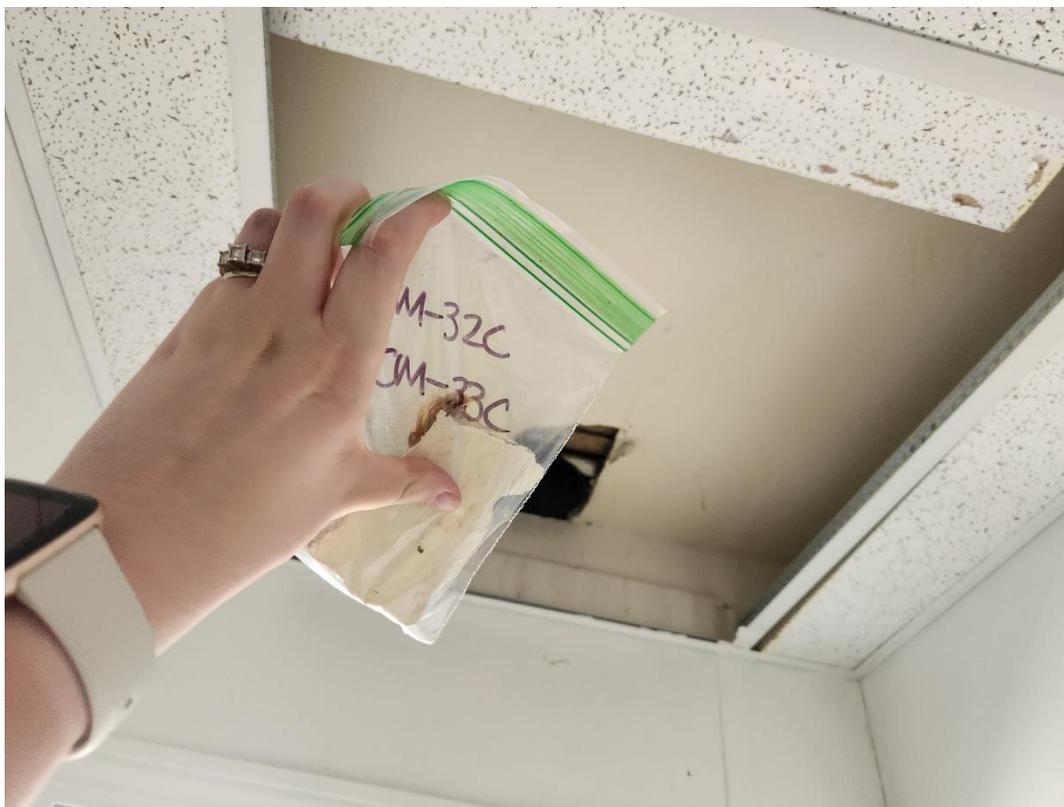
30. View of CA-SACM-32, plaster basecoat, gray, and CA-SACM-33, plaster topcoat, white

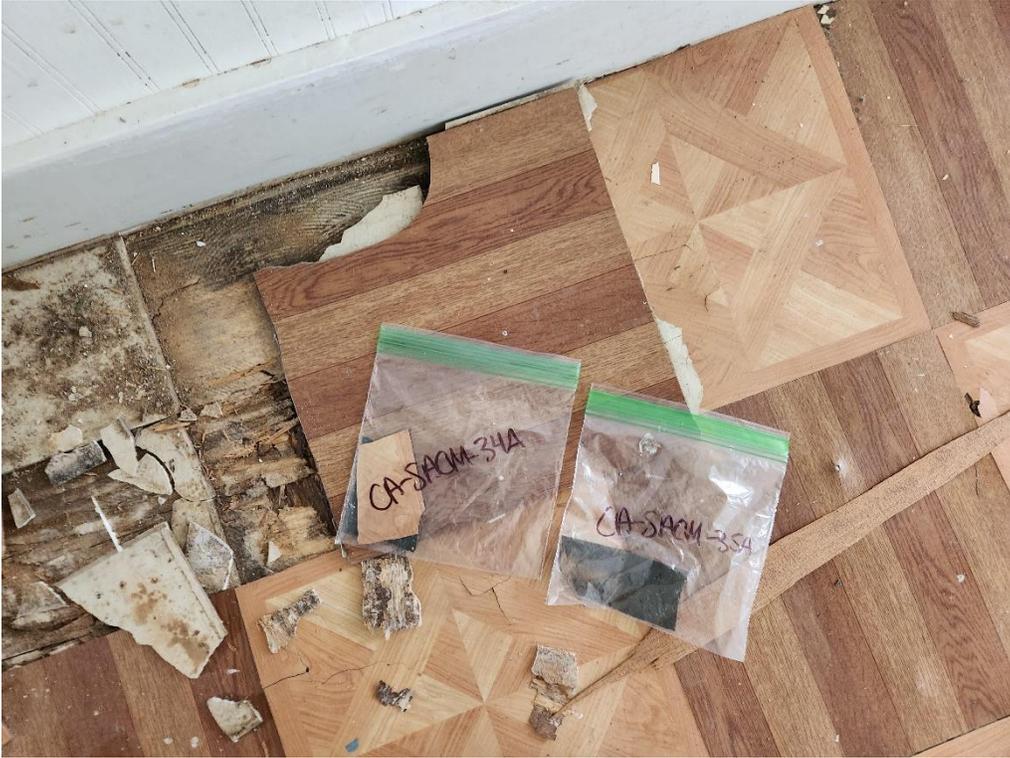
31. View of CA-SACM-34, 12” floor tile, light brown pattern #2, and CA-SACM-35, 12” floor tile, dark brown pattern #2

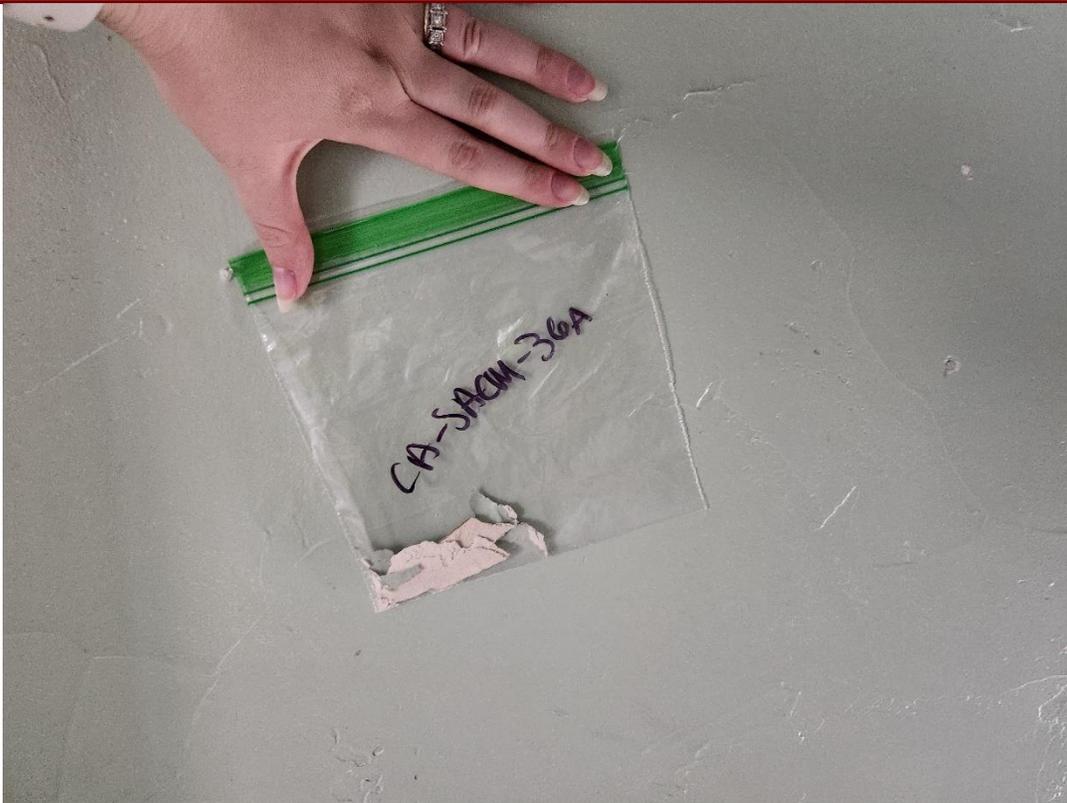
32. View of CA-SACM-36 decorative joint compound, white

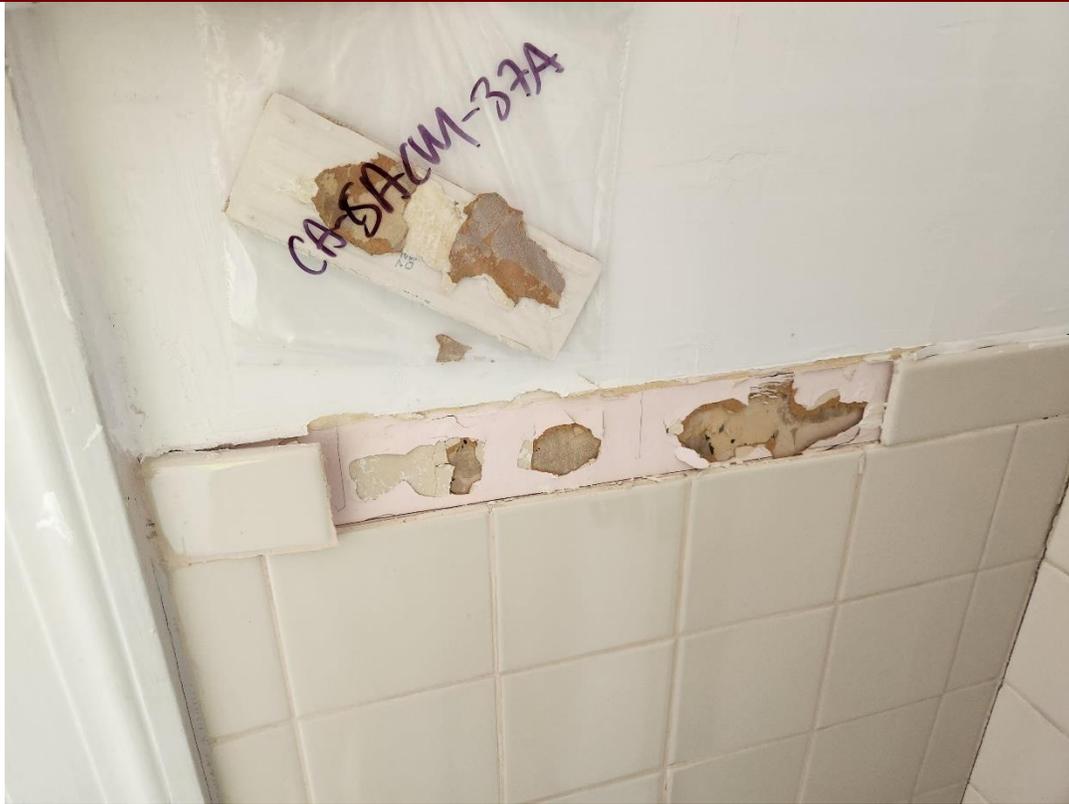
33. View of CA-SACM-37, wall tile underlayment, white

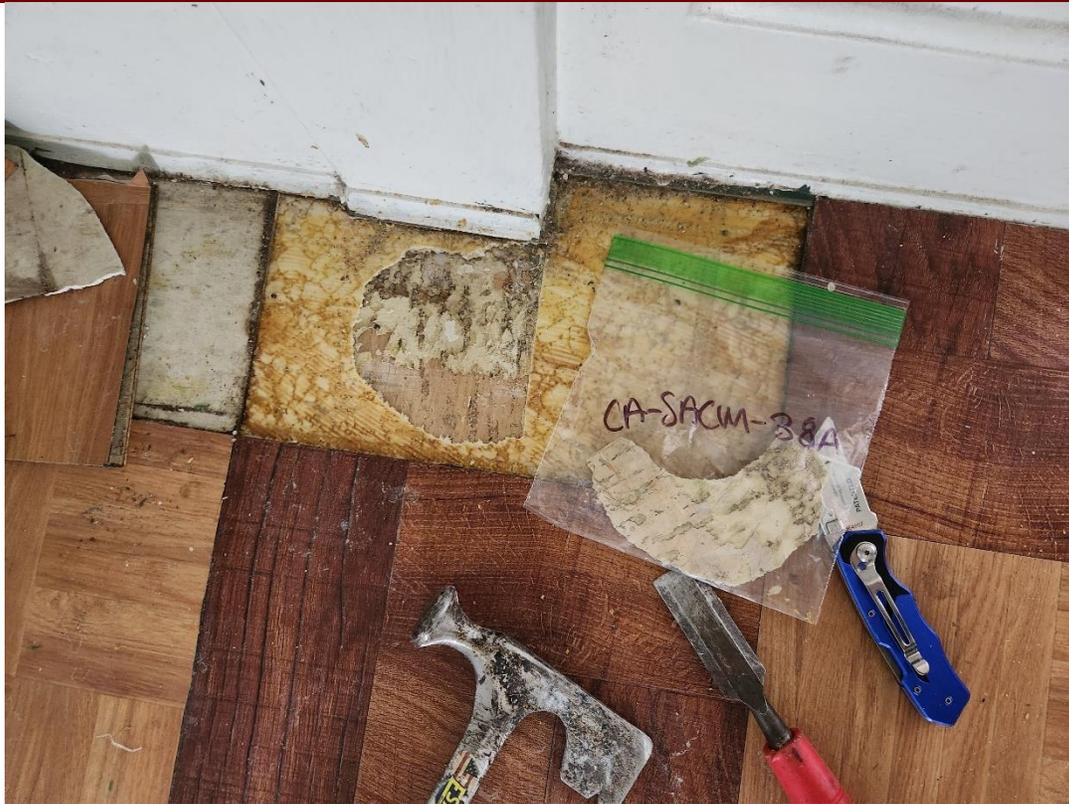
34. View fo CA-SACM-38, linoleum, off white

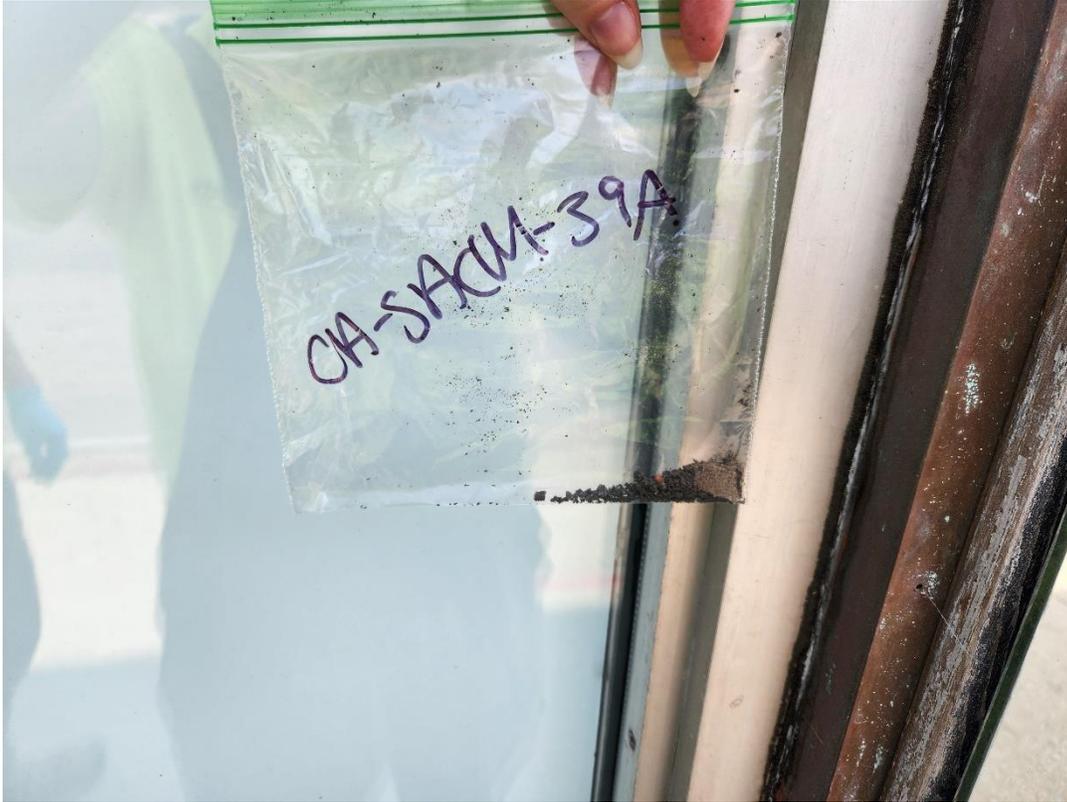
35. View of CA-SACM-39, window caulk, black

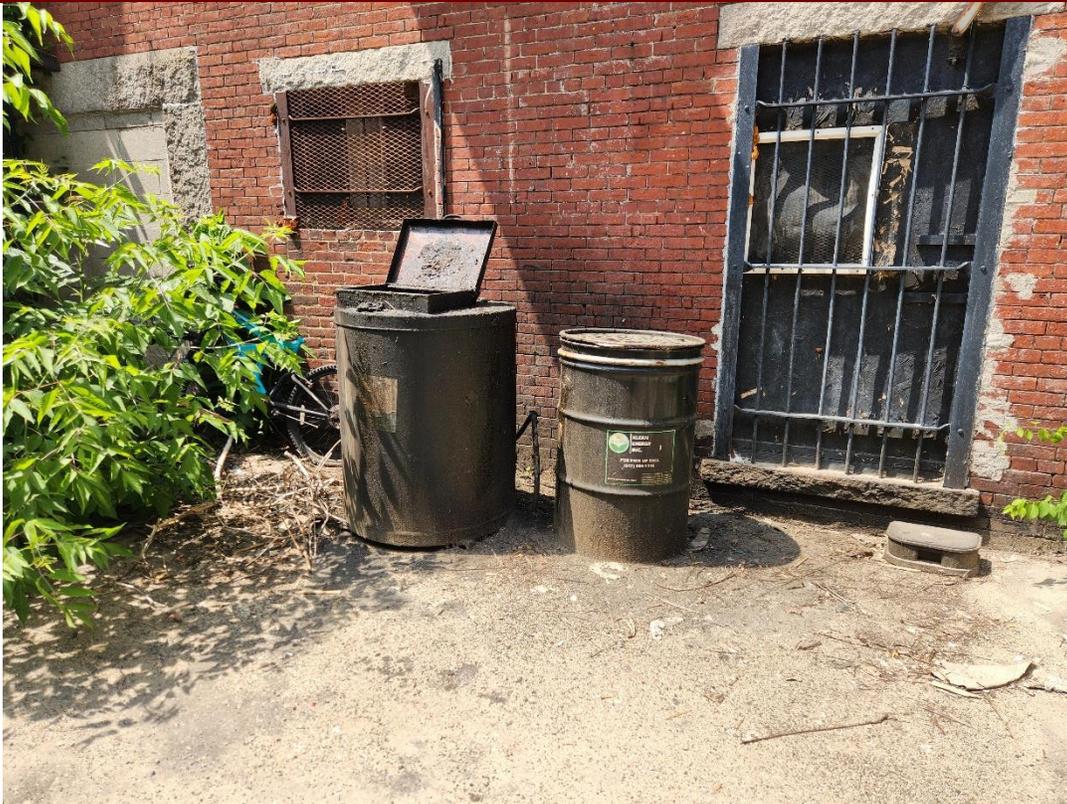
36. View of location of CA-SACM-40, exterior caulk, white, around rear exterior windows

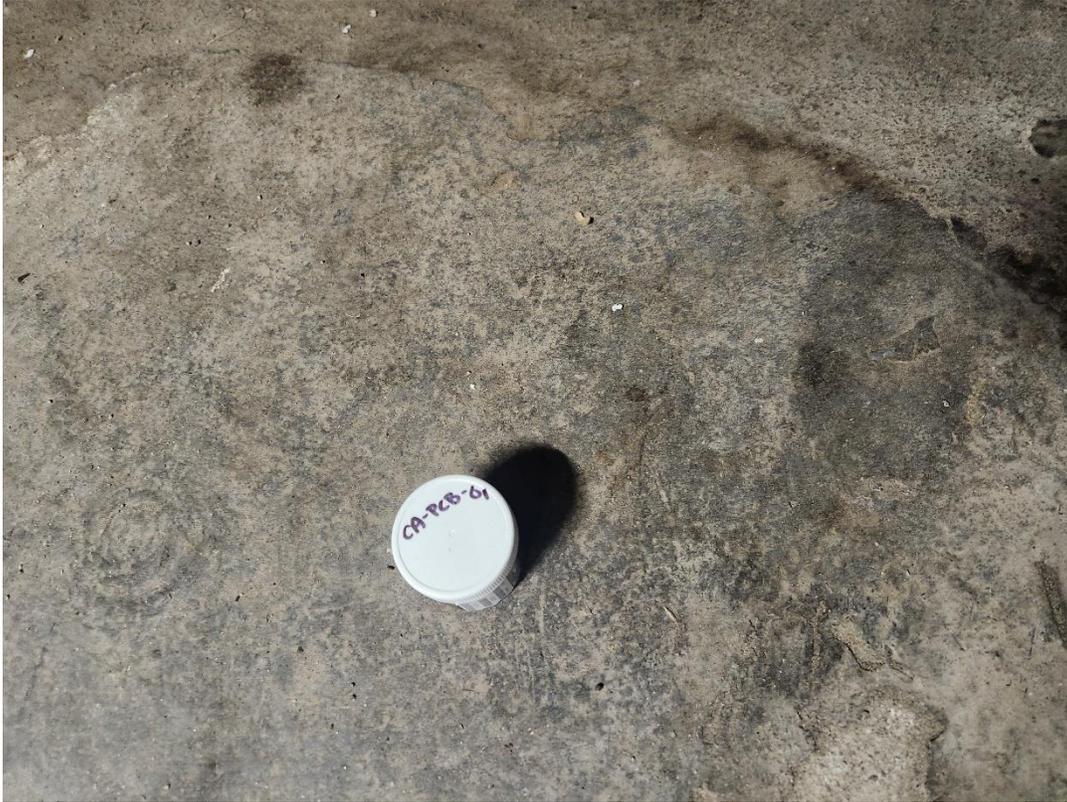
37. View of CA-PCB-01, floor paint, dark gray

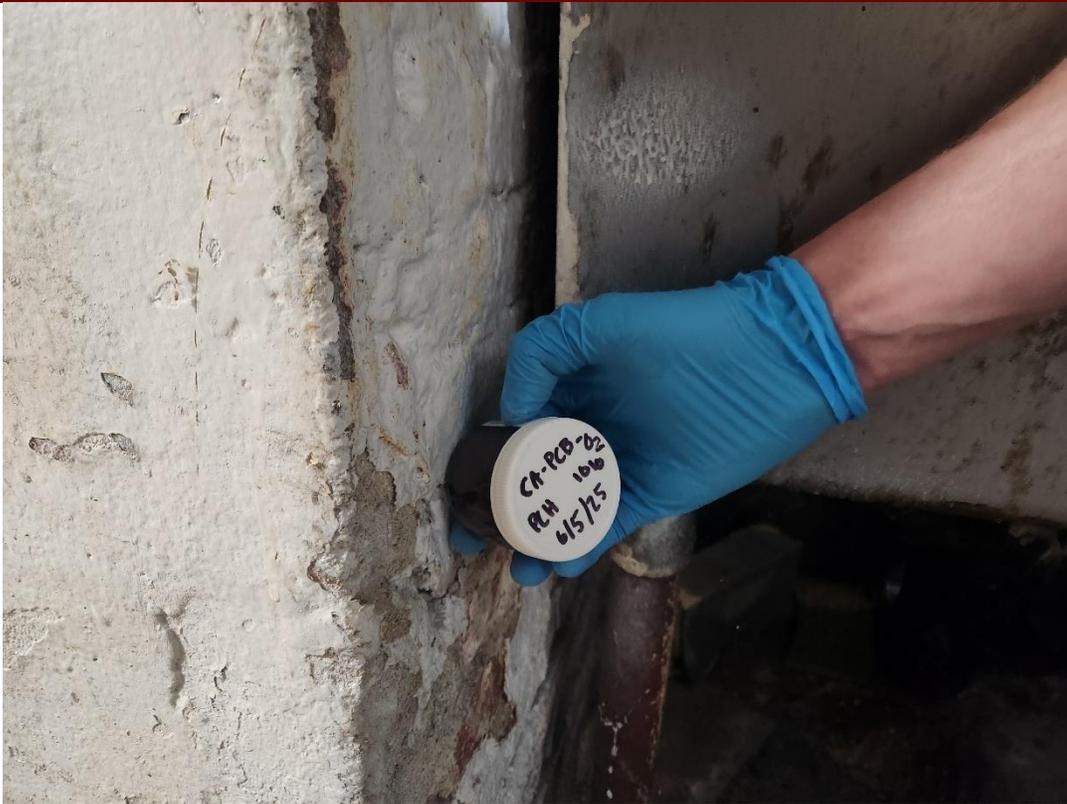
38. View of CA-PCB-02, wall paint, white
