**Subject: Pre-Renovation Hazardous Building Materials Survey
Former A-1 Deli
88-92 Merrimack Street, Haverhill, Massachusetts**

Draft Pre-Renovation Hazardous Building Materials Survey

**Former A-1 Deli
88-92 Merrimack Street
Haverhill, Massachusetts 01830**

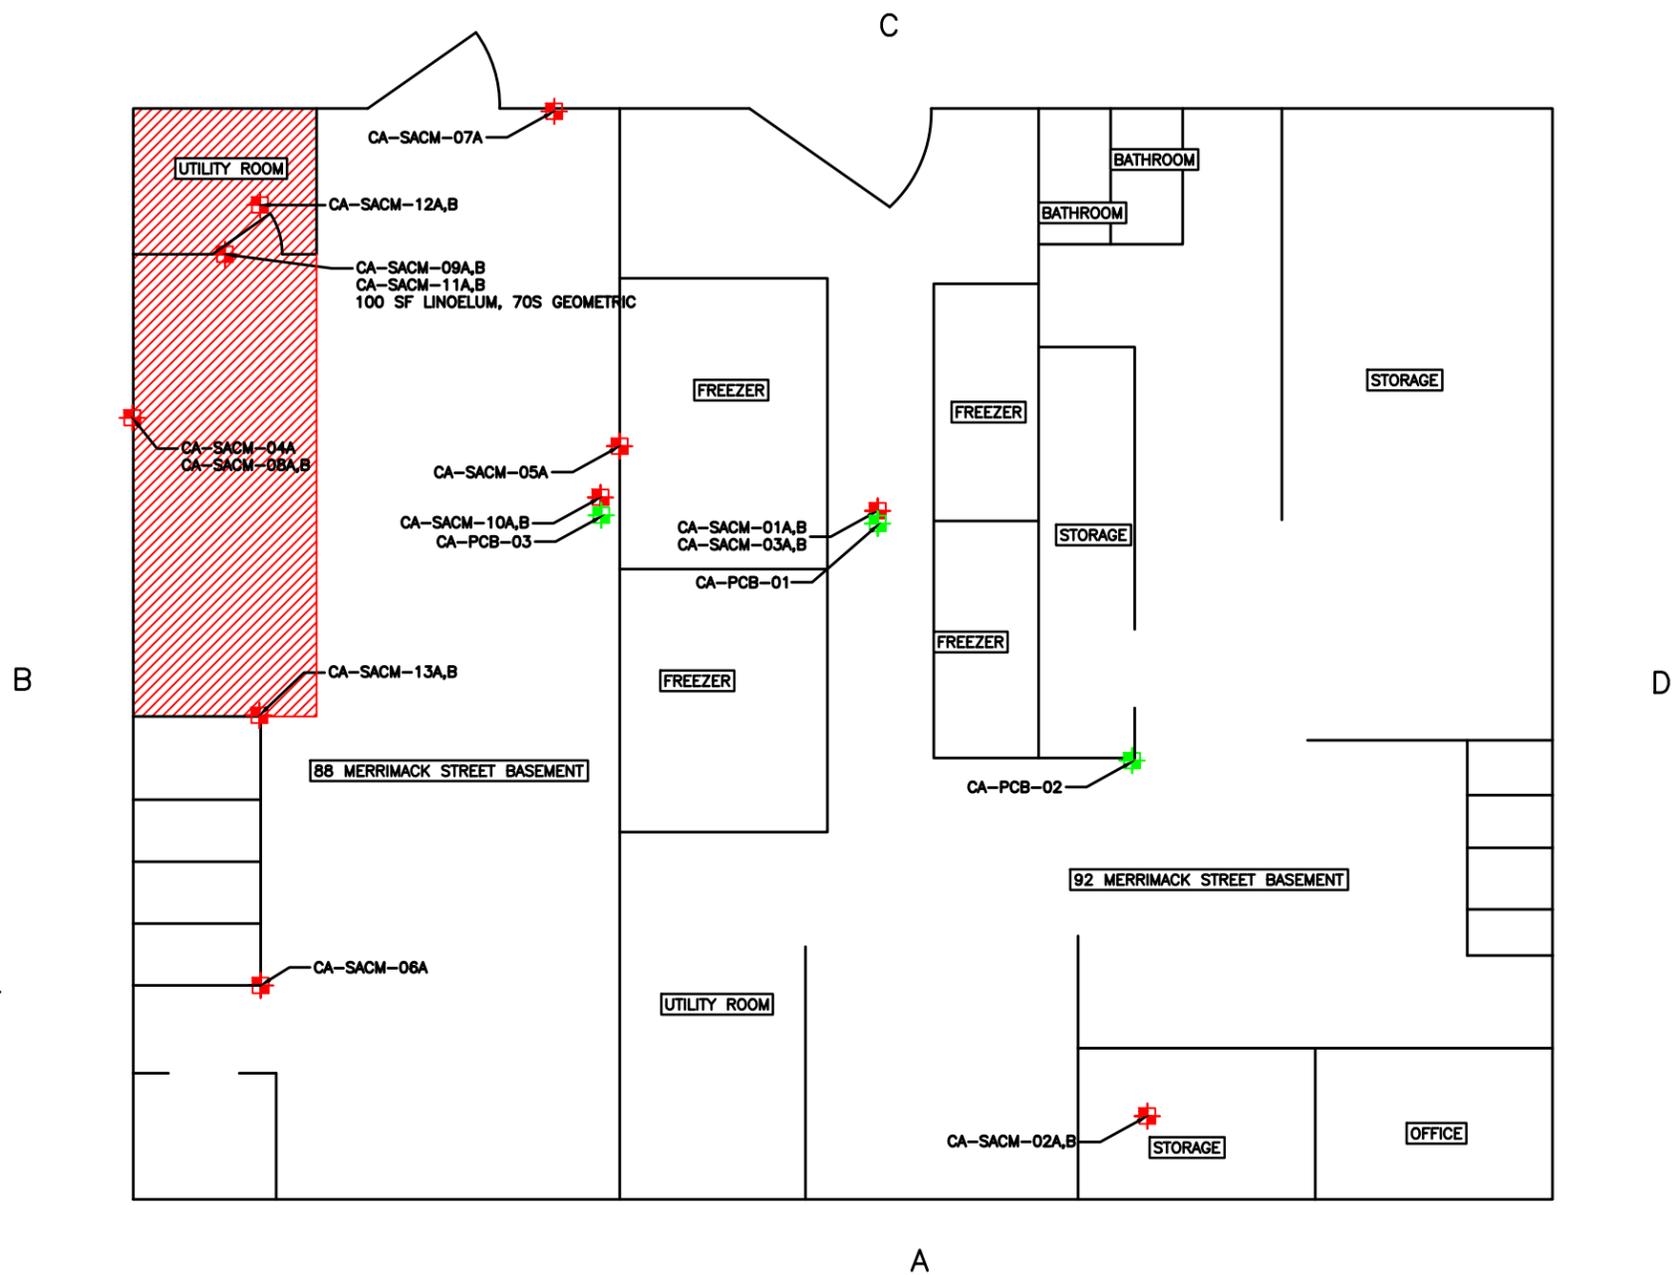
Forty (40) materials were sampled in duplicate, and five materials were sampled in triplicate based on type and square footage. Therefore, a total of 85 individual ACM samples were collected. Photographs of sampled materials are included in **Appendix B**, a Site Location Map is included as **Figure 1**, and building plans showing sample locations are included as **Figure 2** and **Figure 3**.
